## **Chapter 3**

### **Data of the Normal Forces from the Model Tests and Data of the Landslides in Northern Thailand**

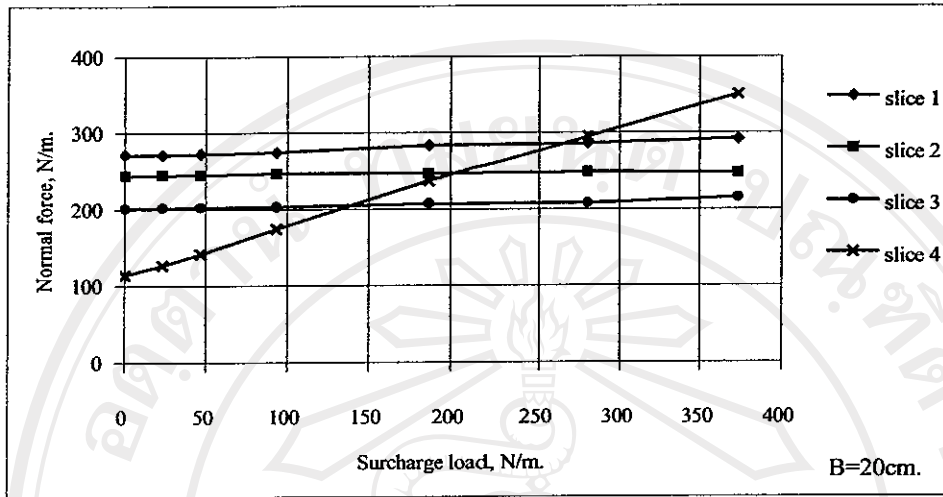
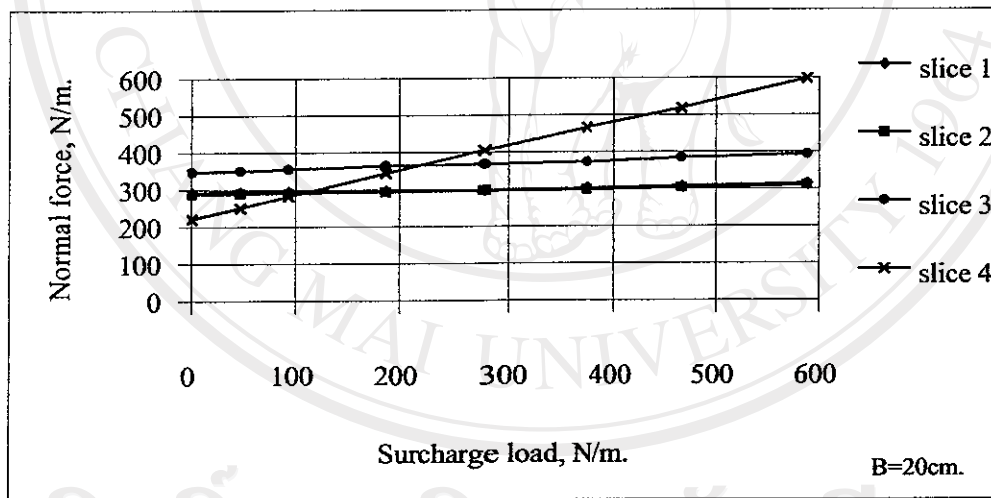
Fig. 3.2 Graph of the normal forces in each slice of the slope model 1 ( $\beta=15.0$  degrees)

According to table A.3-A.5 and fig. 3.2-3.4, it is found that the normal forces acting on the slip surface of almost slice increase in both case (a) and case (b) when the surcharge loads at the top of the slope increase. Especially, the normal force of slice 4 increase in the highest rate because the surcharge loads are almost transferred to slice 4 directly. Although the normal forces acting on slice 1, 2 and 3 rarely increase in the similar rate when gaining the surcharge load, there is an obvious point from the graphs. The increasing rate of the normal forces acting on the slice 3 is higher than slice 2 and slice 1 respectively. The bearing loads effect on the nearer slice than the farther one. Furthermore, the results of the anchoring forces of 3 models do not changed and almost equaled to the first condition of the models (see in fig. A.4; model 1 = 294 N/m, model 2 = 235.2 N/m, model 3 = 196 N/m). The results of the normal forces of slice 3 in case (b) are higher than case, because the anchoring force is directly effect on this slice.

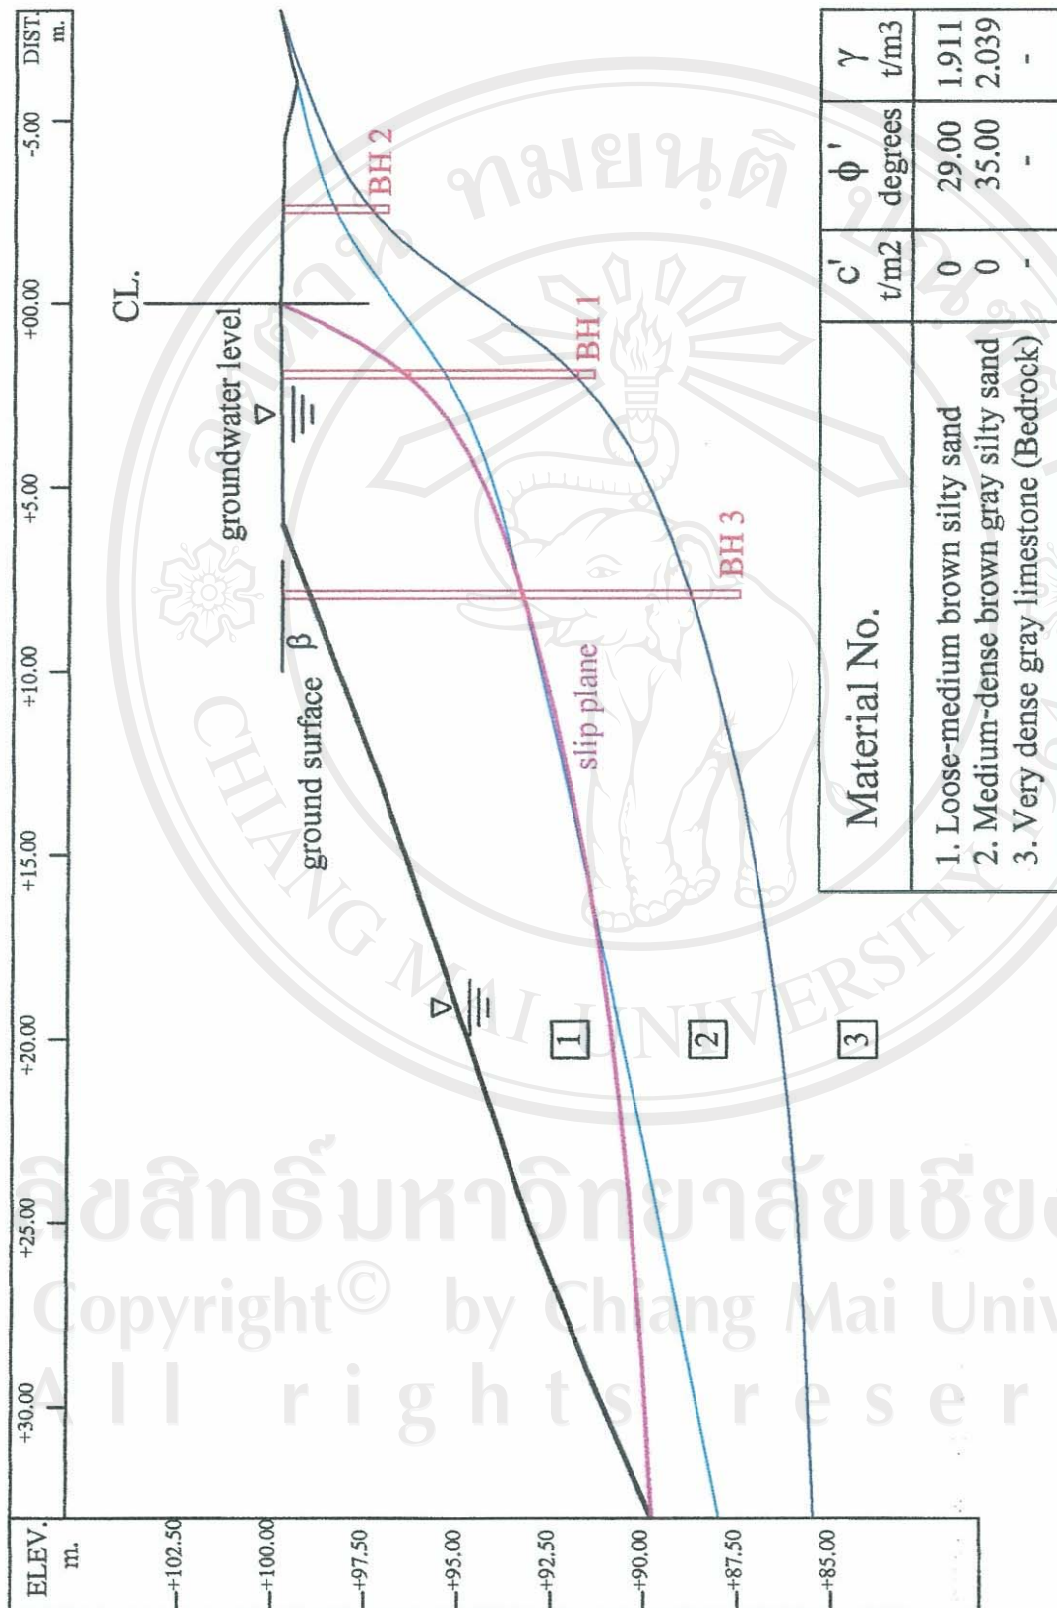
Fig. 3.5 Cross-section of public highway no. 1093 at Km 35+400, Chiang Rai (Source : Bureau of Highway R&D, Department of Public Highways)

Public highway no. 1093, section Km. 29+000 – Patang village, is under a supervision of Payao2 public highway division, Bureau of 2<sup>nd</sup> public highway (Phrae), Public highways department, Ministry of Transport. The route is started to construct in 1993 and had 6 meters width. The severe vicinity is between Km 35+380 and Km 35+440 on the left way. The slope movement took place continuously every year after the construction finished in 1993. The failure happened deep inside to the centre of the traffic lane. The route is under damaged 20 meters long. The primary cause of the soil movement is the groundwater from the back slope on the right way flew through under the road. The accumulative groundwater flew under the road along the connection line between the subbase and the bedrock. Under the condition, the pore water pressure in the soil was higher until the critic and, then, the slope failure occurred.

The geological formation is residual soil and weathered rock of limestone. The soil profile has 3 main layers; Loose-medium brown silty sand, Medium-dense brown gray silty sand and very dense gray limestone (bedrock). The example of boring logs, profile of the route, the sketch of the slope failure and picture are demonstrated in fig. B.1-B.5 (Appendix B).

The typical cross-section of the public highway no.1093at Km 35+400 which is the center of the failure slope is shown in fig. 3.5. In addition to, the soil profile and the actual slip plane are illustrated.

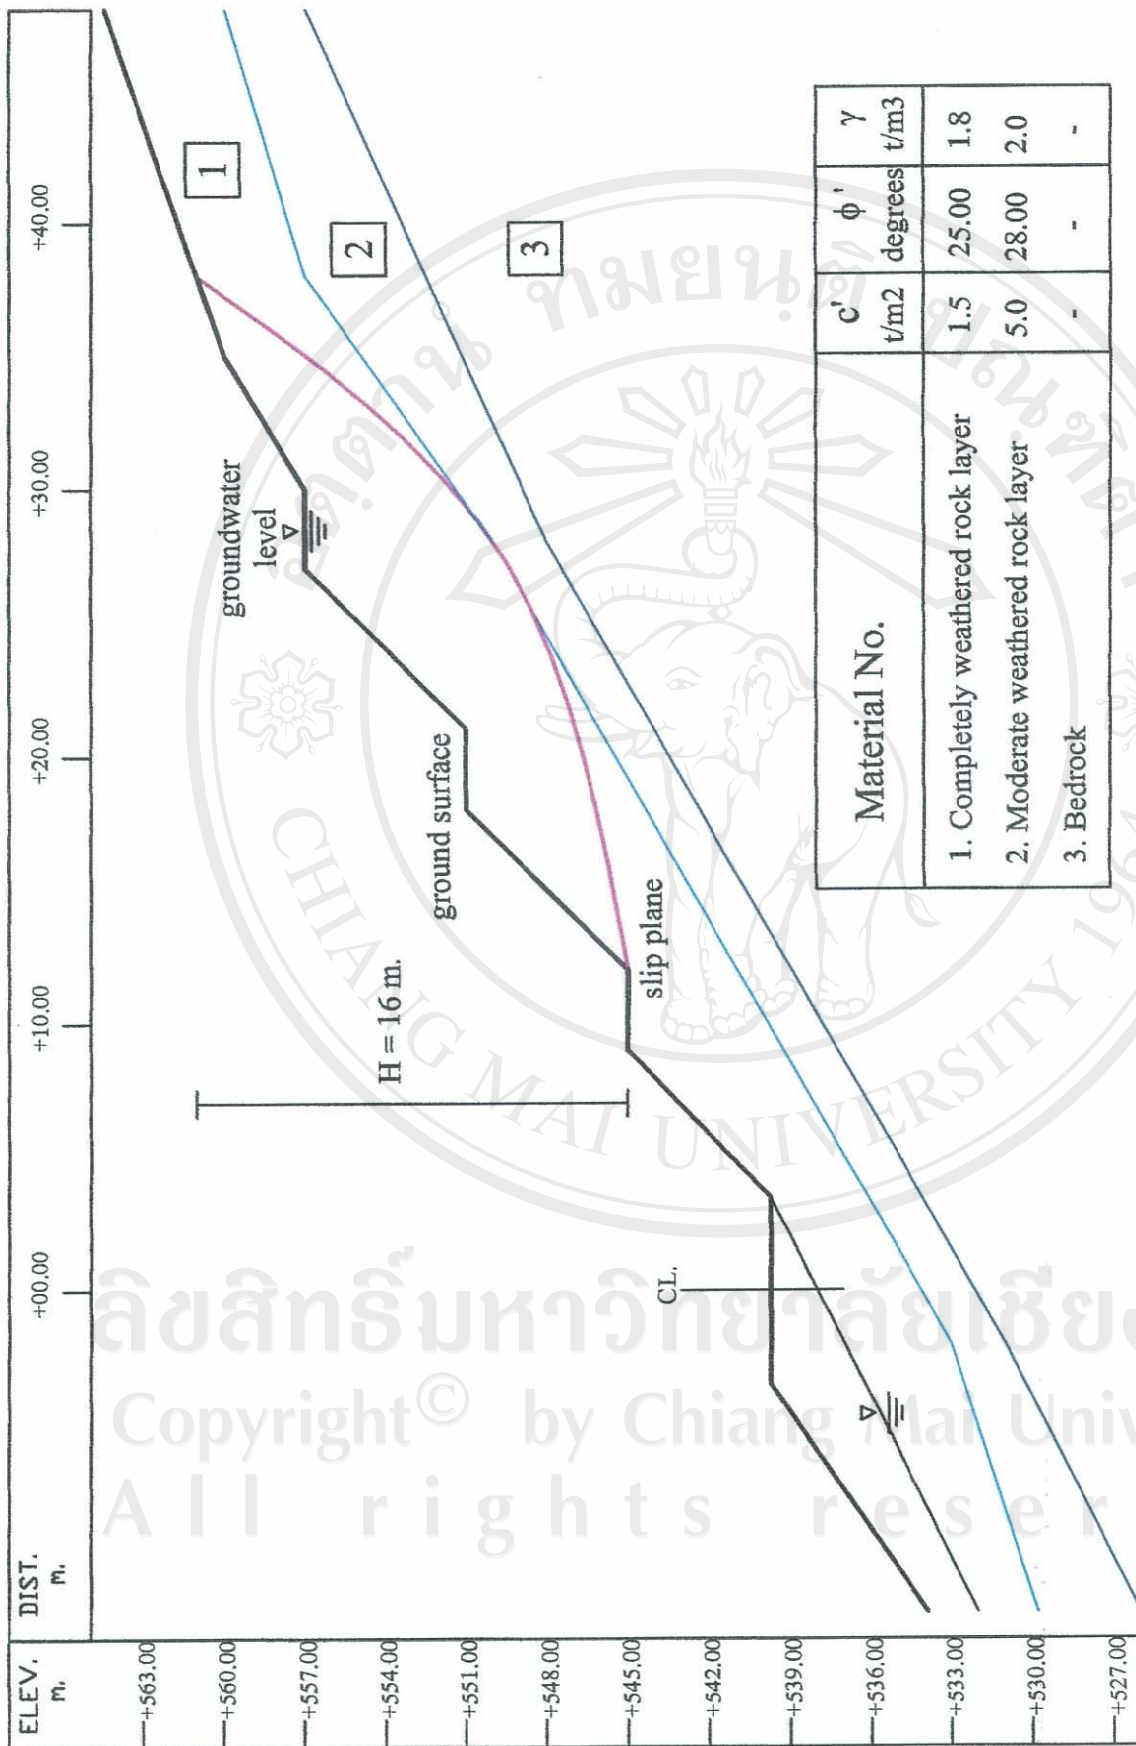
Fig 3.6 Cross-section of failure slope on the left embankment of Mae Laeng Luang Dam, Chiang Mai (applied from Mairaing, 2000)

Mae Laeng Luang Dam is rather big, small type earth dam in the project of the agricultural product distribution in Northern Thailand. The geological formation is residual soil and weathered rock of granite and basalt. The slope failure occurred during the construction in the period of cutting the slope upon the spillway on the left embankment. The cause is cutting the slope through the low strength soil area and the effect of the heavy rainfall. Then, the slope failure occurred.

The type of failure is shallow seated rotational slide and the position of failure surface is slope failure surface. The cross-section of failure slope is demonstrated in fig. 3.6. From the failure, the budget of the construction was lost to improve the slope. The improvement method is rock berm and hand dug pile. The re-improvement finished in 1994.

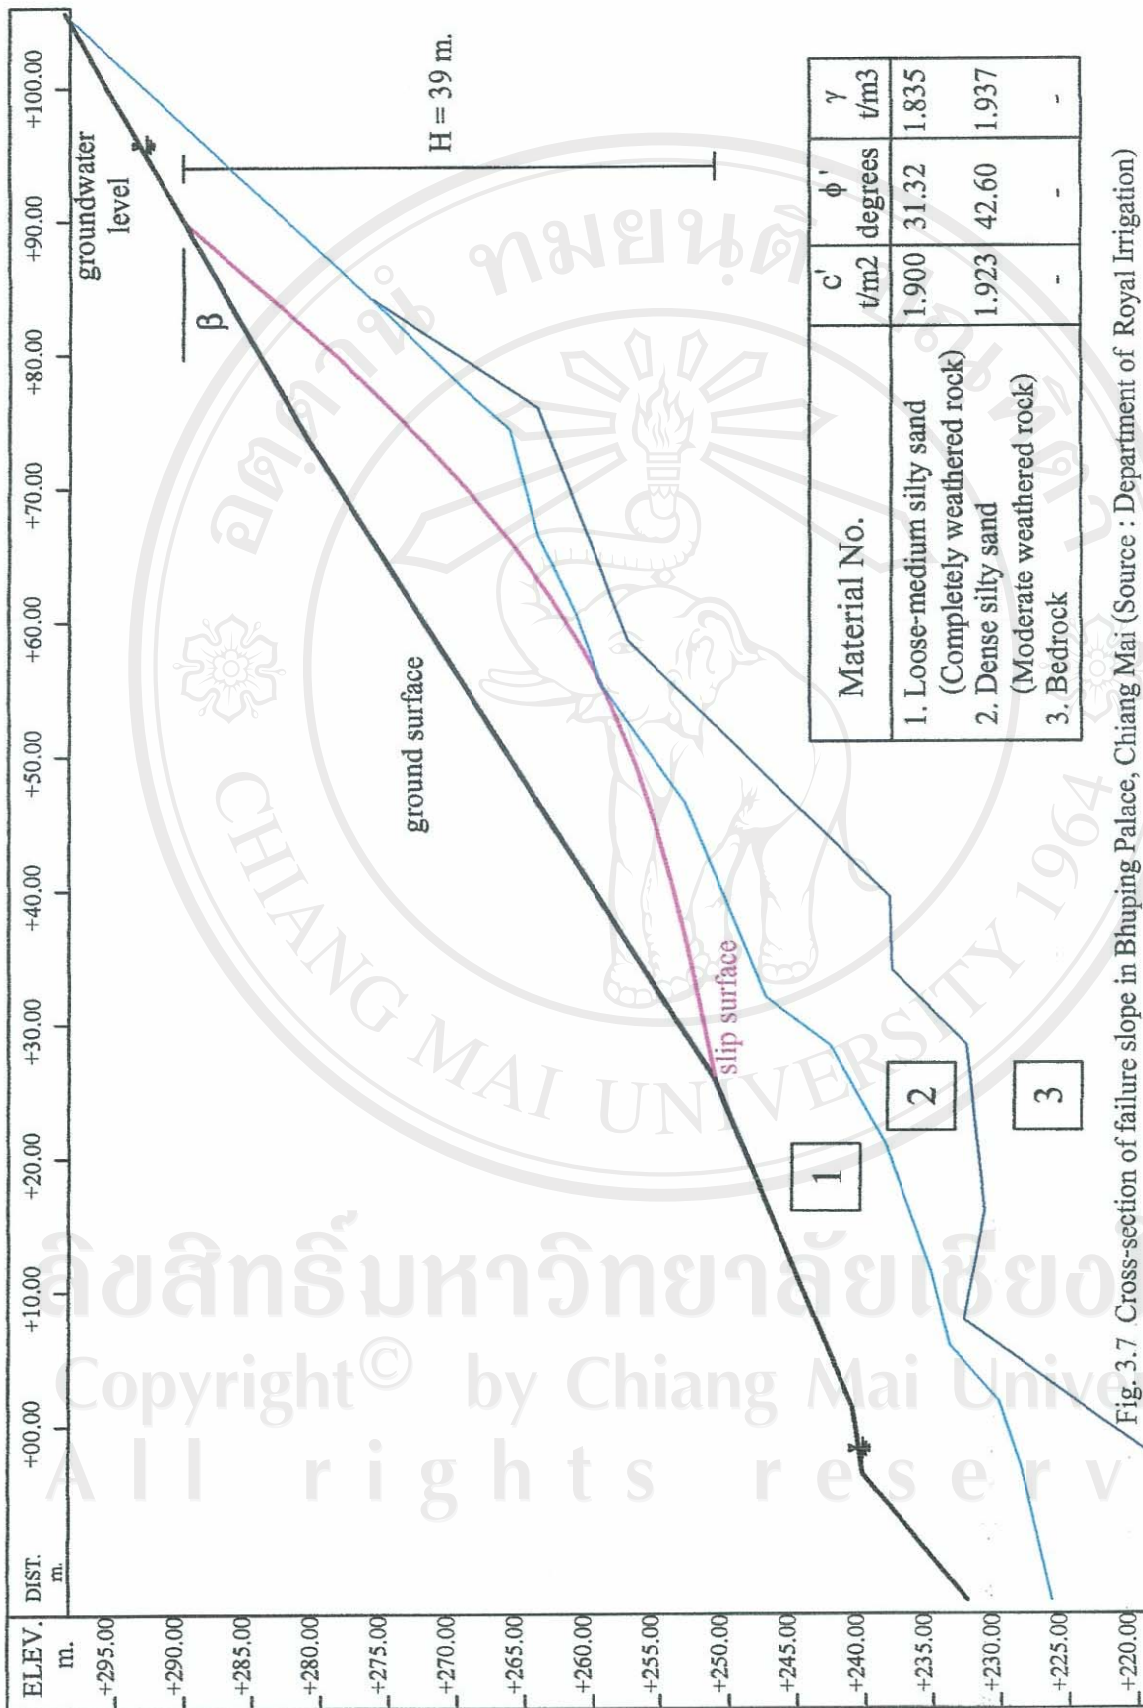
Fig. 3.7 Cross-section of failure slope in Bhuping Palace, Chiang Mai (Source : Department of Royal Irrigation)

The mountain slope failed because of the water drainage of 15,000 m<sup>3</sup> reservoir flow through the residual soil and weathered rock slope. The geological formation is the residual soil and weathered rock of granite which can classify in SM-SC group (USCS). Type of failure is shallow seated rotational slide. The failure slope has approximately 50 meters wide. But, at the lower slope, there is another drainage channel which made the failure shape bigger and inexact shape. The plan and the profile of slope are shown in fig. B.8 (Appendix B). Line A-A' is the center line of the failure slope. The cross-section of the failure slope is illustrated in fig. 3.7.

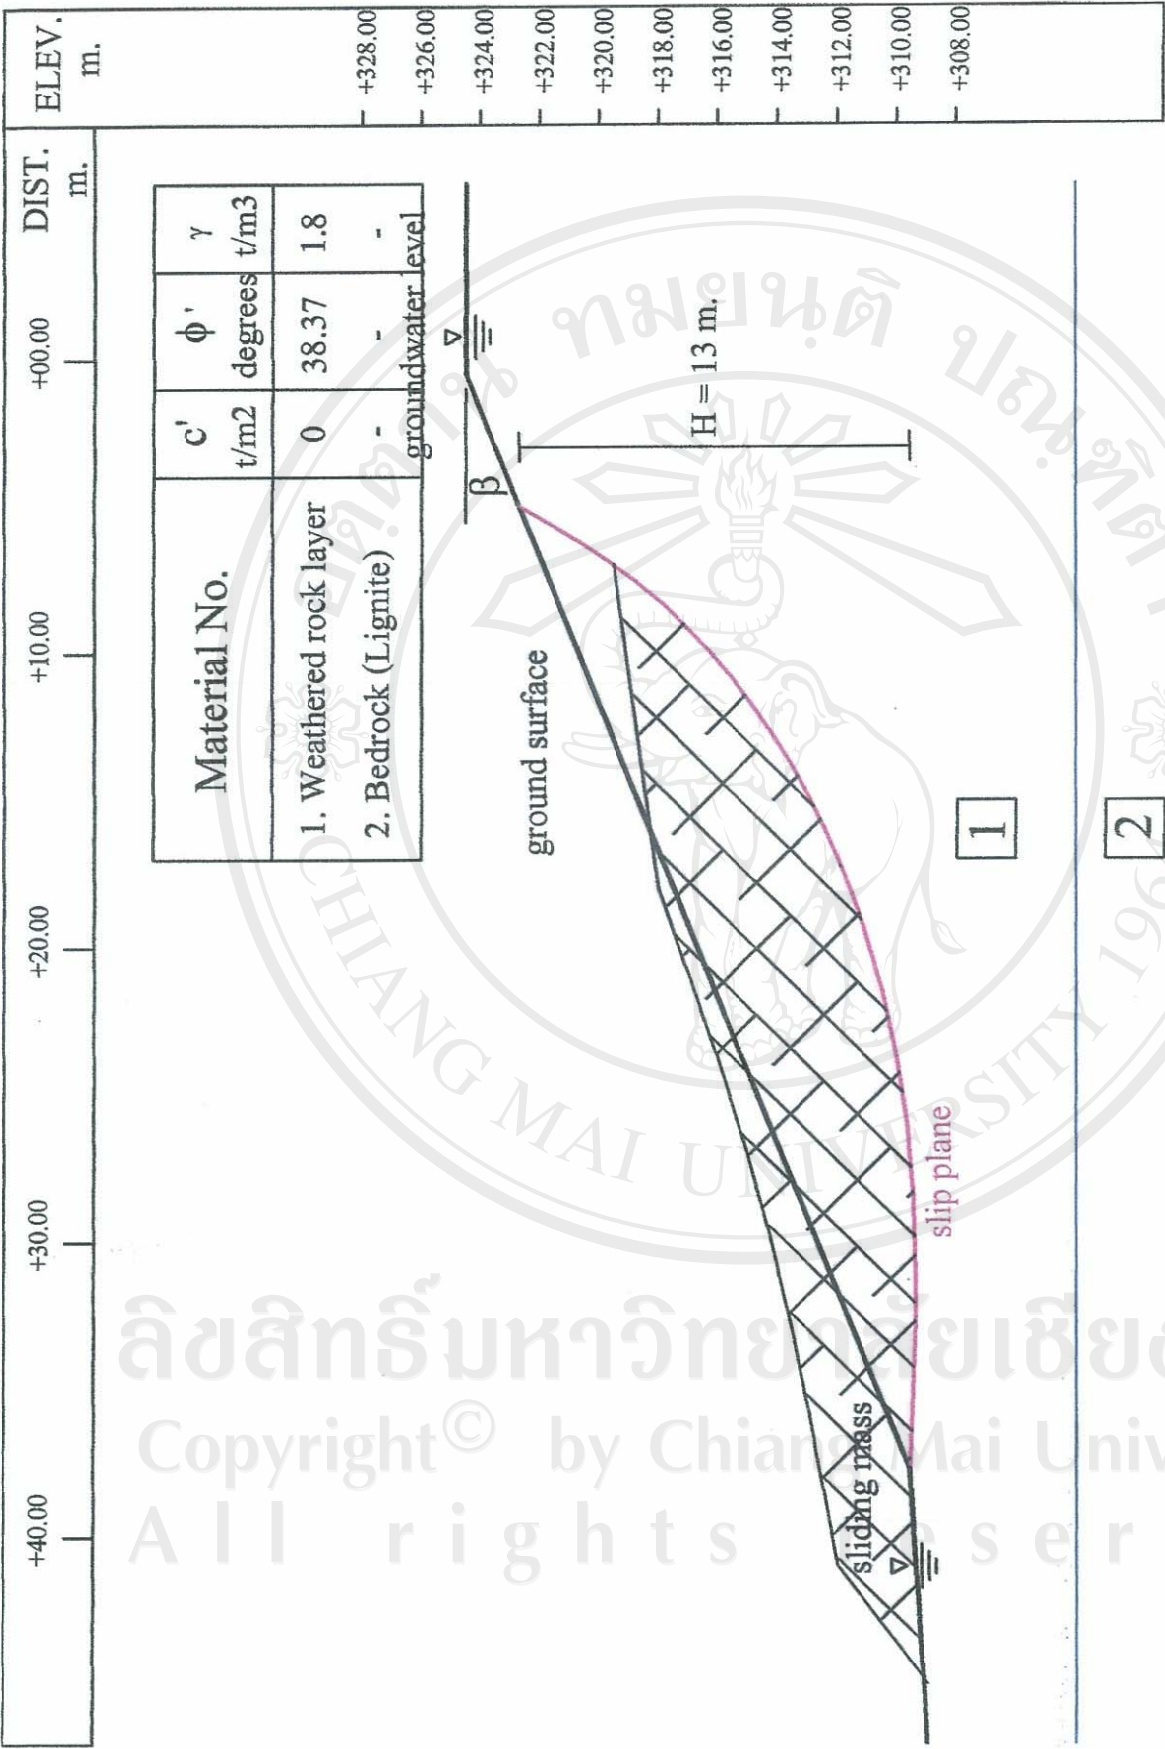
Fig. 3.8 Example of the shallow seated rotational slides failure slope in Mae Moh Mine, Lampang

Mae Moh Mine is an open-pit of lignite for the materials to make an electric power. The geological formation is the residual soil and weathered rock of yellowish green claystone in the upper soil layer, and the lignite is in the next layer. The final layer of lignite is about 200 meters deep under the ground (“d” in fig. 3.8) with a perimeter of approximately 12 km. Although the efficiency slope stability checking is utilized in Mae Mo Mine, there is the happening of many slope failures. Almost failure slopes are taken place from the mountain slope cutting through the low strength soil area and the fault plane in the upper soil layer. The height of slope is about 15-40 meters and the slope inclination angle is about 20-35 degrees. The types of encountered slope failures are the planar slides along the fault plane and the shallow seated rotational slides. Fig. 3.8 shows the example of failure slope, which has shallow seated rotational slide failure type. The position of failure slope is at the toe of the failure slope. The slope has 13 meters high (H) and 22 degrees of inclination angle ( $\beta$ ) according to fig 3.8. The profile plan of the failure slope is illustrated in fig. B.7, section B-B’ (Appendix B).
