Chapter 4

Case study: Doi Suthep, Chiang Mai

This chapter mentions geological surveys, field testing and laboratory testing of slide on the public highway no. 1004 (section of Chiang Mai municipal government to Doi Suthep-Palace) between Km. 13+832 and Km. 13+875 which is similar to the general earth slopes in Northern Thailand. Also given in this chapter is a failure surface of the slide which estimates with profile and cross-section of the route and soil profile. More details are shown in section 4.5.

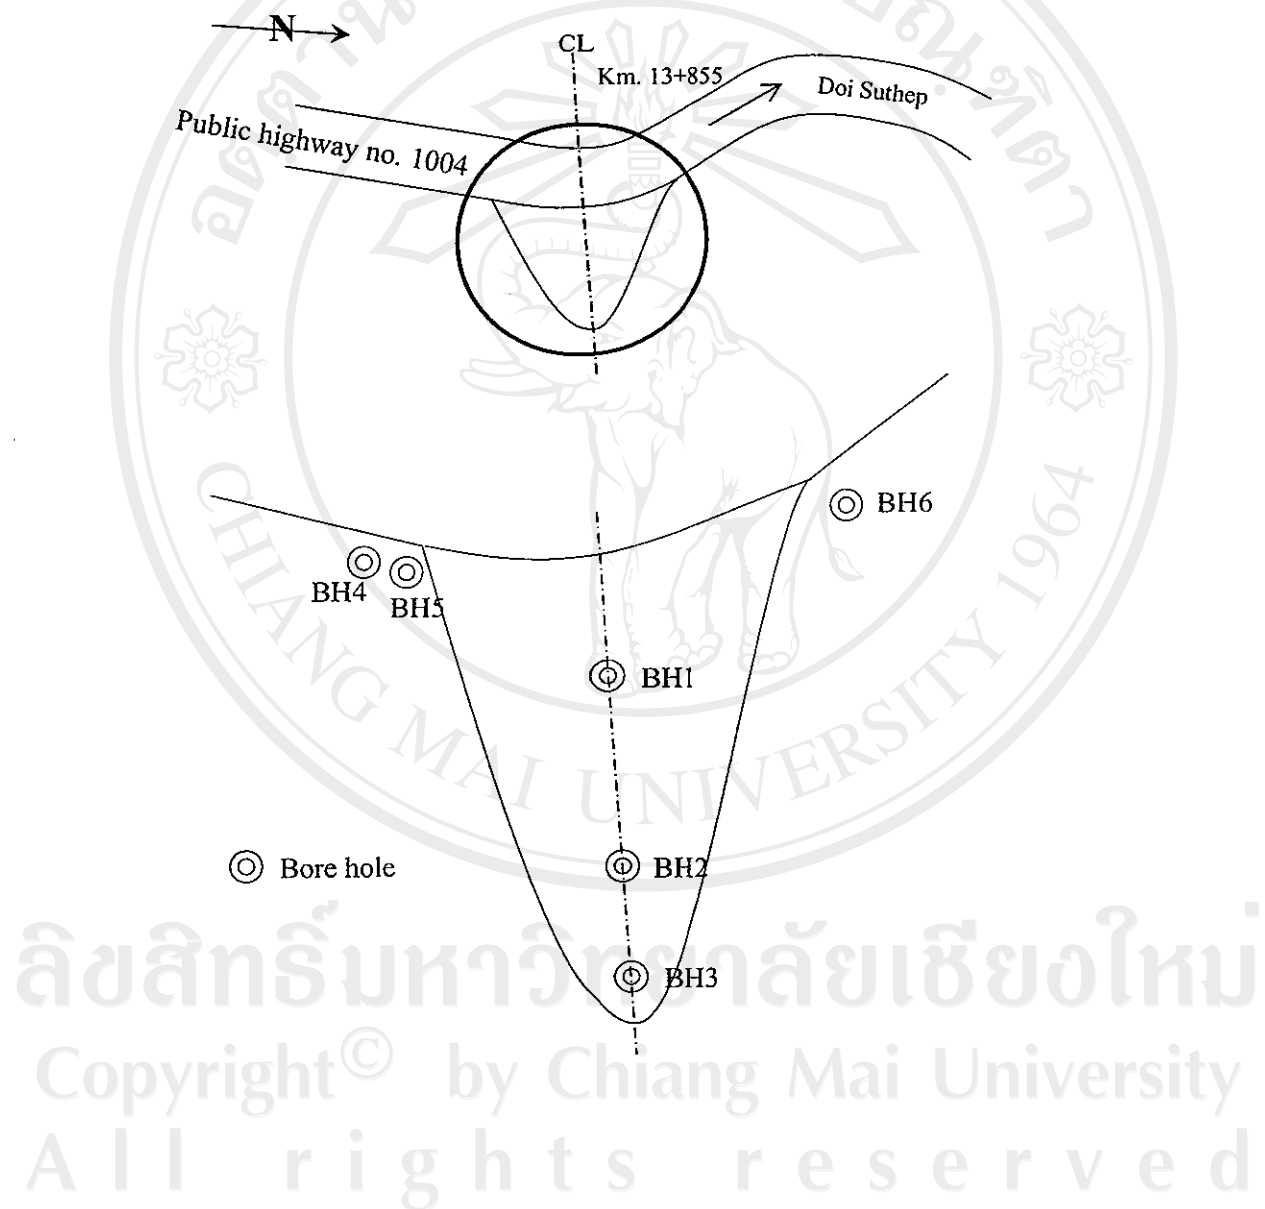
Fig. 4.1 The location of the failure slide in Doi Suthep, Chiang Mai and bore holes to do soil sampling

The boring tests are drilled in 6 holes (BH1, BH2, BH3, BH4, BH5 and BH6). The locations of all bore holes are demonstrated in fig. 4.2. At the cross line of Km. 13+855 of the highway no. 1004, which is the center line of the slide, BH1, BH2 and BH3 are drilled spread to the toe of the slide to determine the slip plane and the geological condition under the slip plane. The other holes (BH4, BH5 and BH6) are drilled on the left and the right side, out of the sliding area to find the original shear strength parameter of soil and soil condition. The depth of each bore holes should be drilled through the slope failure plane or until the bedrock. Details of boring tests are described in Appendix C.

The soil profile of the failure slide area is shown in fig. 4.1 and table 4.3 shows the average values of the soil properties in each group.

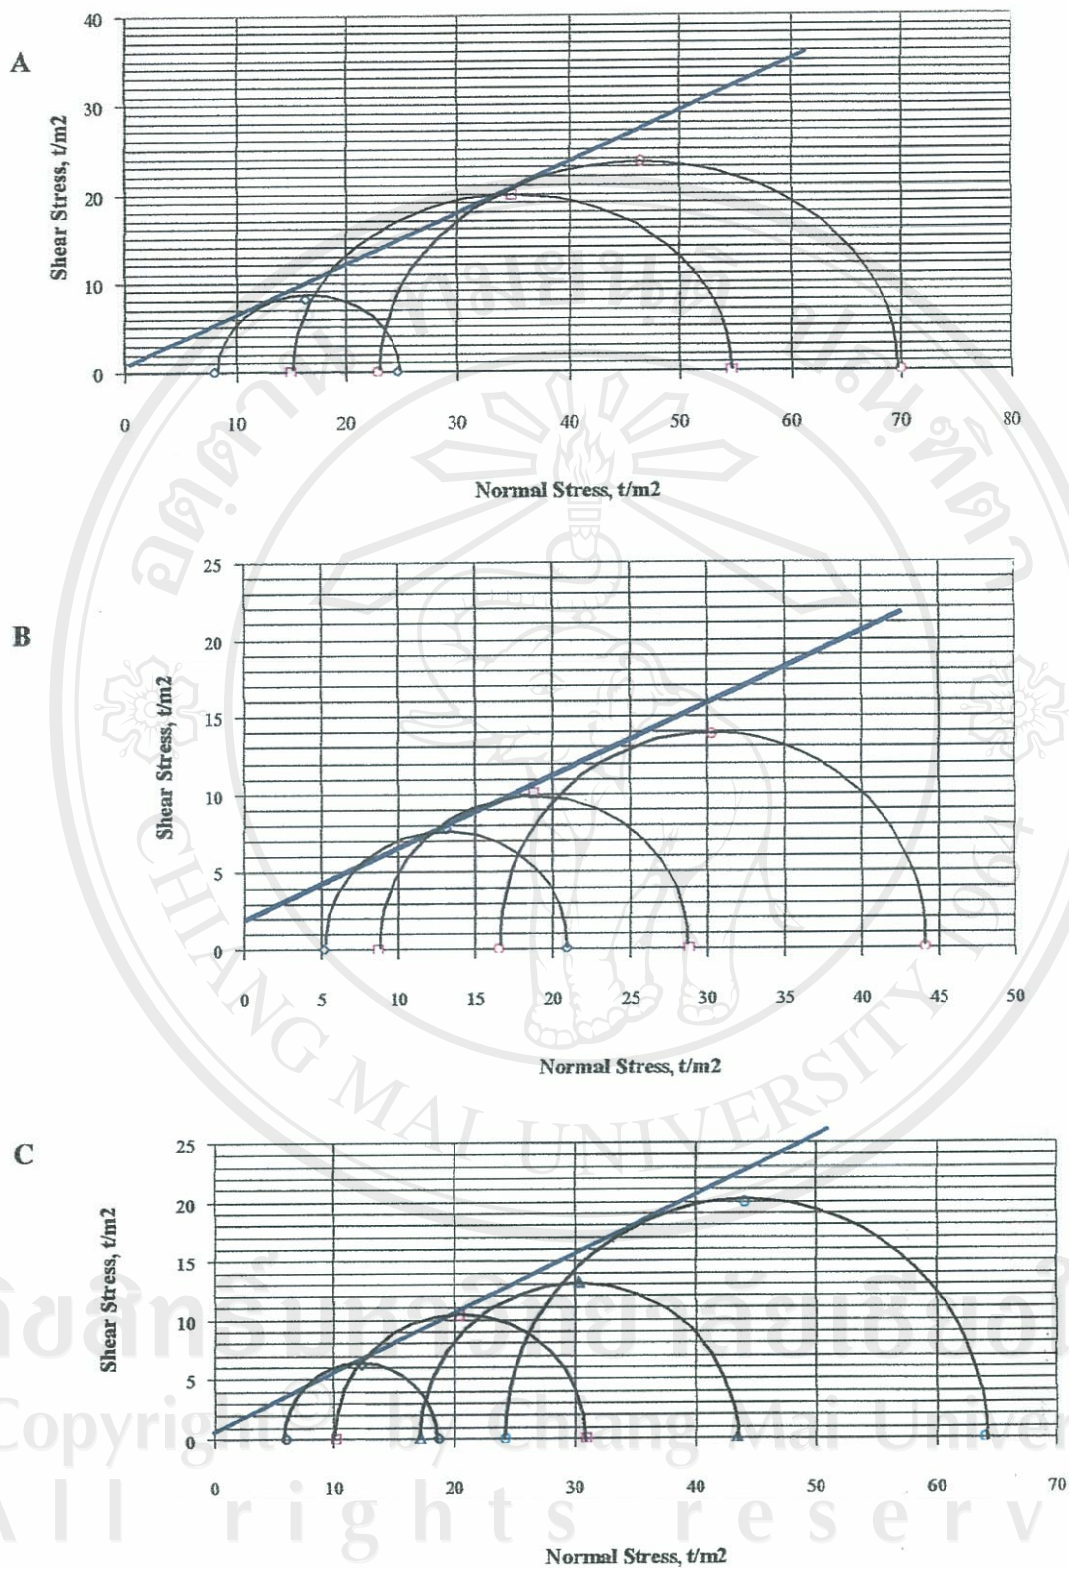
Fig. 4.2 Mohr's circle of sample A, B and C

The results of the effective shear strength parameter of soil for each layer are shown in table 4.4, which obtained from Mohr's circle of sample no. A, B and C in fig. 4.2.

Soil layers	Effective shear strength parameter of soil	
	c' (t/m^2)	ϕ' (degrees)
a) Upper layer	1.1	25.8
b) Intermediate layer	0.5	31.0
c) Moderate to slightly weathered rock	0.0	38.0

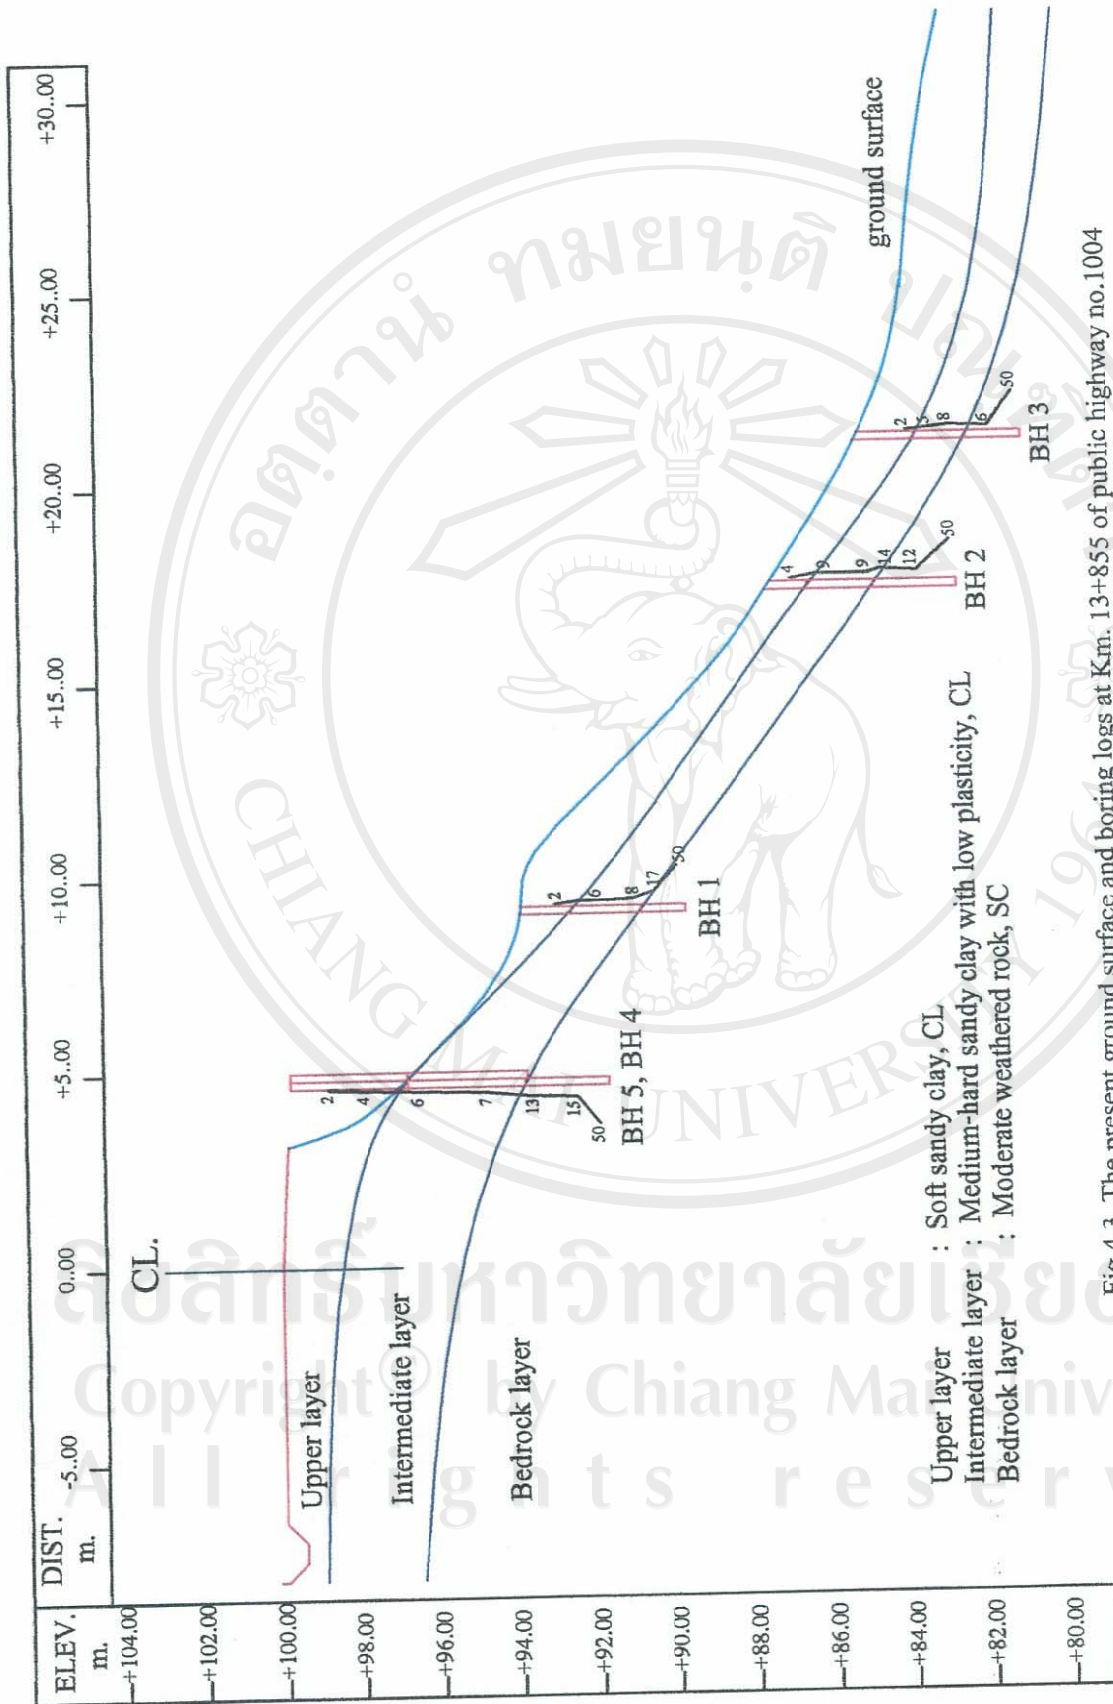
Fig 4.3 The present ground surface and boring logs at Km. 13+855 of public highway no.1004

From the field observation and topographic survey (by theodolite T2), the present ground surface of the centerline of failure slope is illustrated as the thin light blue line in fig. 4.3 including location of boring logs and SPT results. The shape of ground surface line indicates the occurrence of slope failure. The soil moved to the toe of the slope, but the sliding mass is still in the failure area as shown in fig. 4.3 and fig. C7-C8 in the appendix C. BH1, BH2 and BH3 are drilled along the centerline down to the toe of the slope to determine the slip plane and the soil conditions under the slip plane. BH1 started to drill from the moving mass area, thus the top of BH1 is the zone of sliding mass, which can be defined by the small value of SPT. BH4 and BH5 are drilled in the outer area of the slide on the left side to find the original ground condition, and to collect undisturbed samples to do the triaxial test. From all data of boring logs, field tests and the results of laboratory tests, the geological condition can be divided into 3 soil layers; the upper layer, the intermediate layer and the weathered rock layer, which the details are previously described in the section 4.4. According to fig. 4.3, it can be seen that the failure zone might occur in the upper layer, which the soil is soft sandy clay.

It is obvious from the soil profile in fig. 4.3 that the upper soil layer has low strength and it is not enough for slope to be stable for a long time under the severe weather and heavy rainfall. The soil layer, therefore, leads to many problems in civil engineering.

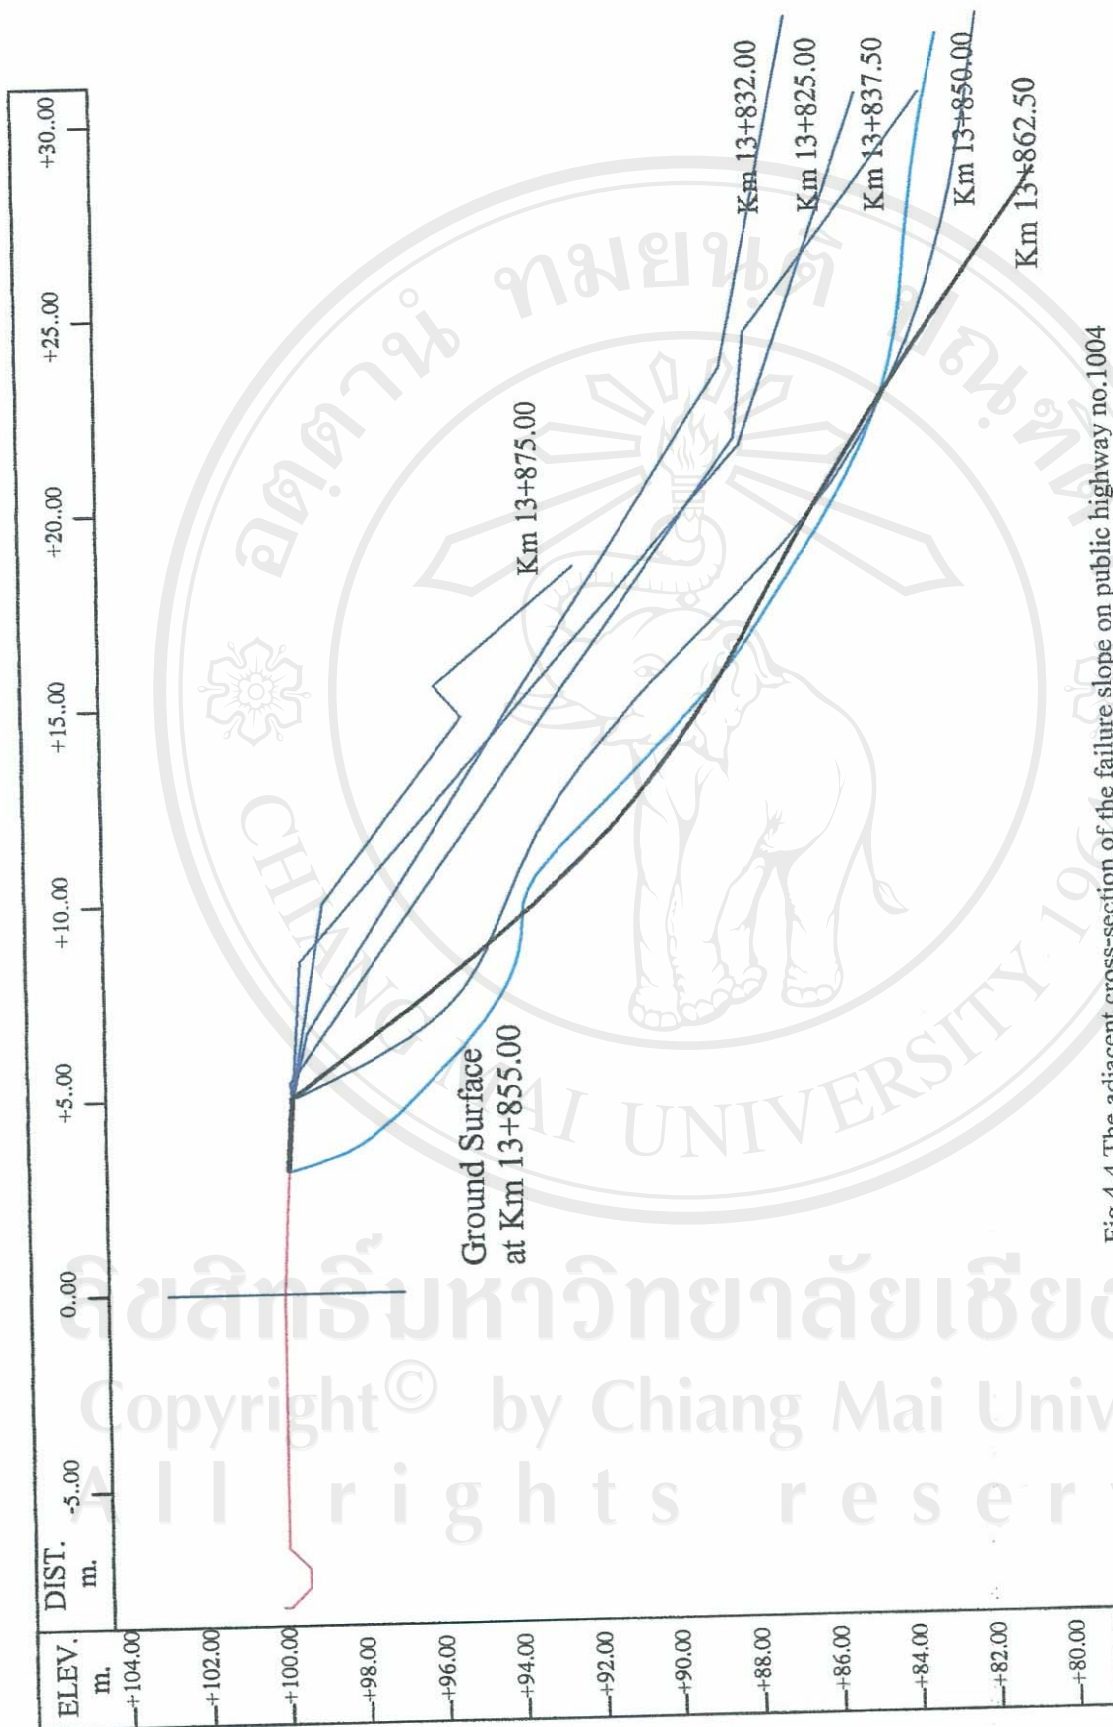
Fig 4.4 The adjacent cross-section of the failure slope on public highway no.1004

13+832.00, 13+ 837.50, 13+850.00, 13+862.50 and 13+875.00) as demonstrated in fig. 4.4. From the shape of cross-section of Km. 13+850.00, it is implied that there is a partly failure at this section. The next higher cross-section, Km. 13+862.50 or the lower cross-section, Km. 13+837.50 might be represents the original ground surface at the centerline of the slope. When compared the original ground surface of both sections and the present ground surface at Km. 13+855.00, it is found that the ground surface of Km.13+862.50 is possible to be the original ground surface, because the ground surface is related to the actual sliding mass.

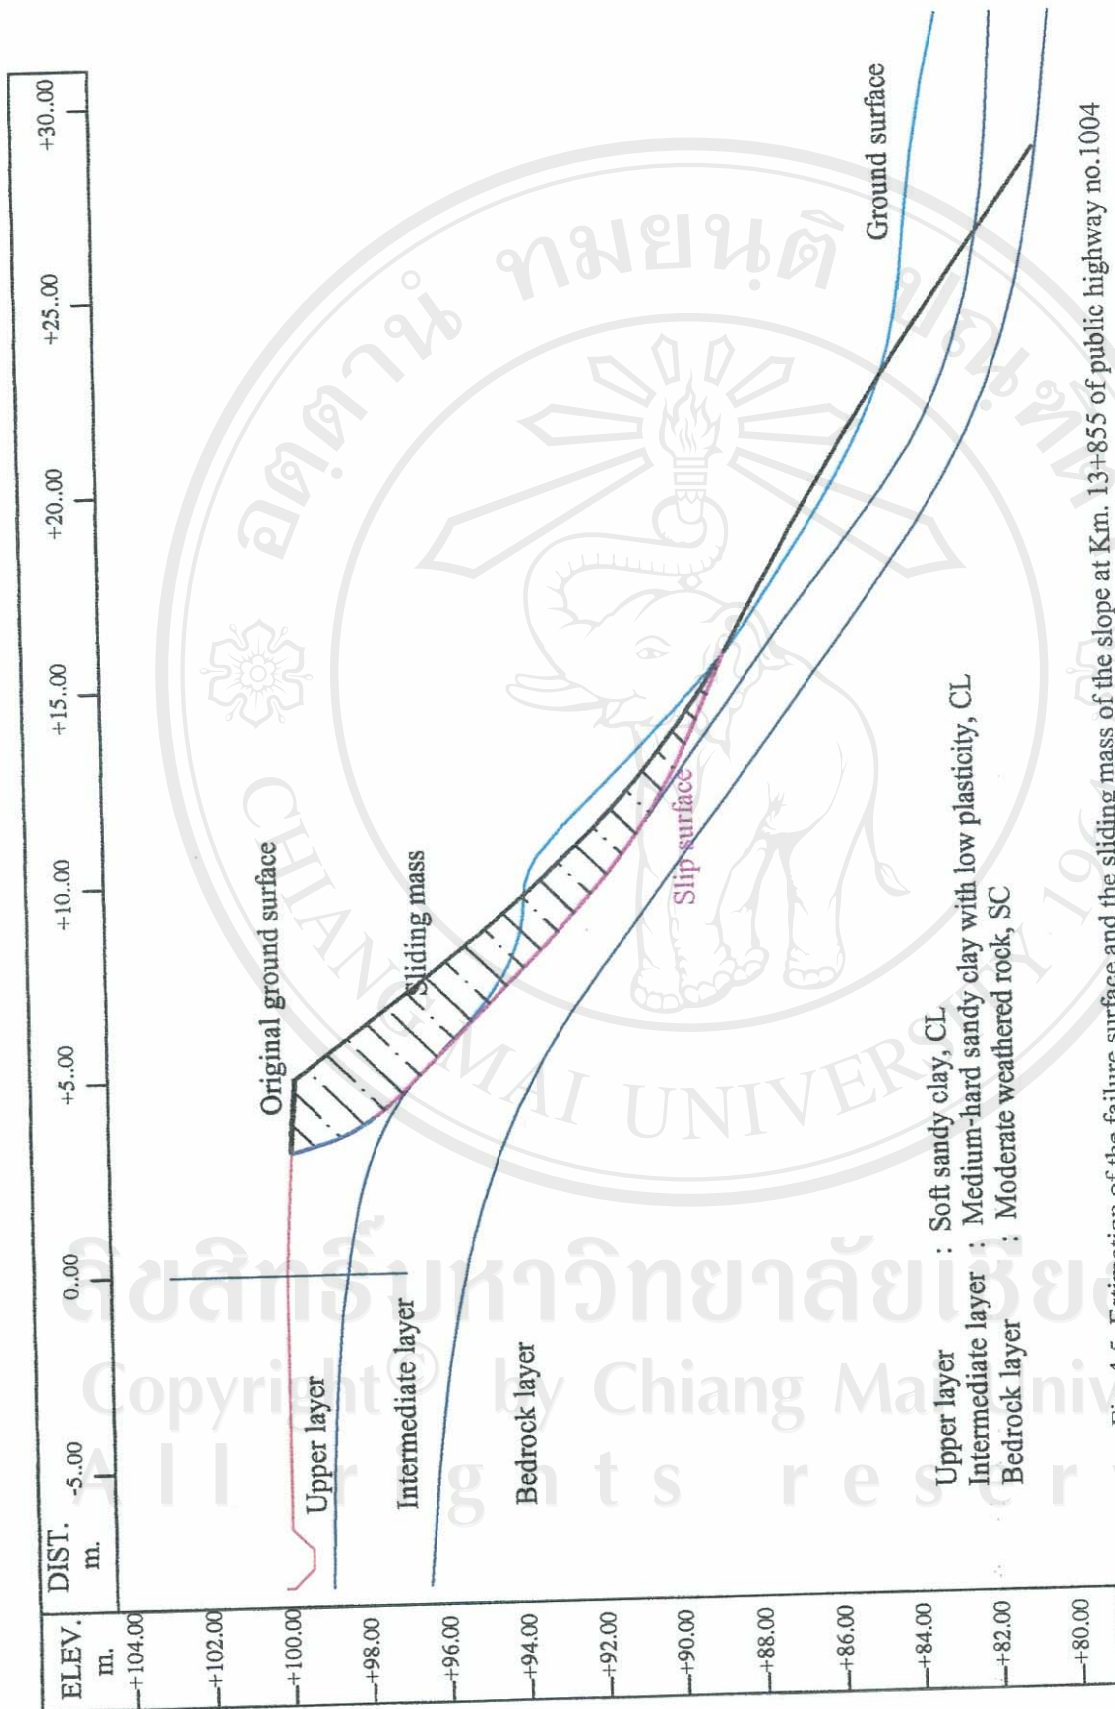
Fig. 4.5 Estimation of the failure surface and the sliding mass of the slope at Km. 13+855 of public highway no. 1004

From the site investigation, at the upper zone of the slope, the upper ending point and some parts of the slip line can be assumed by the visual because there are no sliding mass in the upper zone. And the lower ending point of the slip line can be assumed by some clues in the field (e.g. the changing of the characteristic of the soil, the color of the soil and the humidity). Since the both ending point and some points of the slip line are assumed by site investigation and the small value of SPT and CPT (1-4 blows/ft) of BH1 indicated the failure mass or the unstable zone of the slope. And the type of slope failures of almost landslides in Northern Thailand is non-circular shallow seated rotational slides (Yamsai and Mairaing, 2000). Therefore, the slip line can be assumed by drawing as the pink line in fig. 4.5. According to the original ground surface in fig. 4.4 and the failure surface in fig. 4.5, the sliding mass is the hatched area in fig. 4.5.
