## CHAPTER 3

### SITE DESCRIPTION

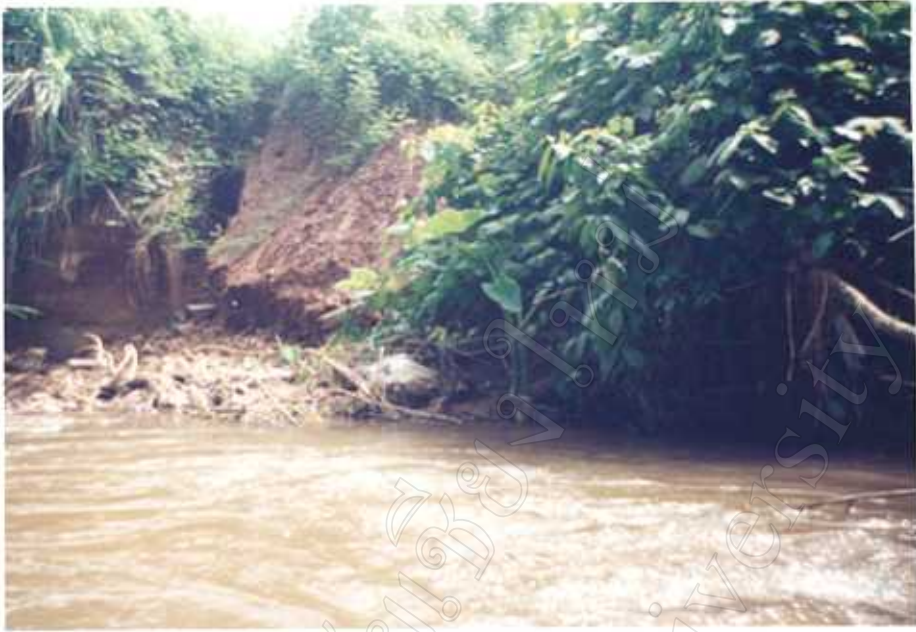
*Figure 2: Study site ST 1 in Stream. Note landslide occurred in wet season.*

This site is in the upper watershed area of Mae Sa, at Ban Muan Khun, in Mae Rim district, Chiang Mai province. This stream runs through several agricultural areas as well as elephant camp sites. This site is threatened by road construction nearby. The researcher observed during the rainy season that the landslide at this site affected the stream structure (Figure 2).

The stream bed was partly shaded by riparian vegetation. The organic substrate component included about 90-95 % of detritus (mainly logs) and 5-10 % muckmud. Most of the inorganic part is bed rock and the rest includes mainly stones, sand and silt. Average stream width is 8.25 m, and depth is 0.54 m.

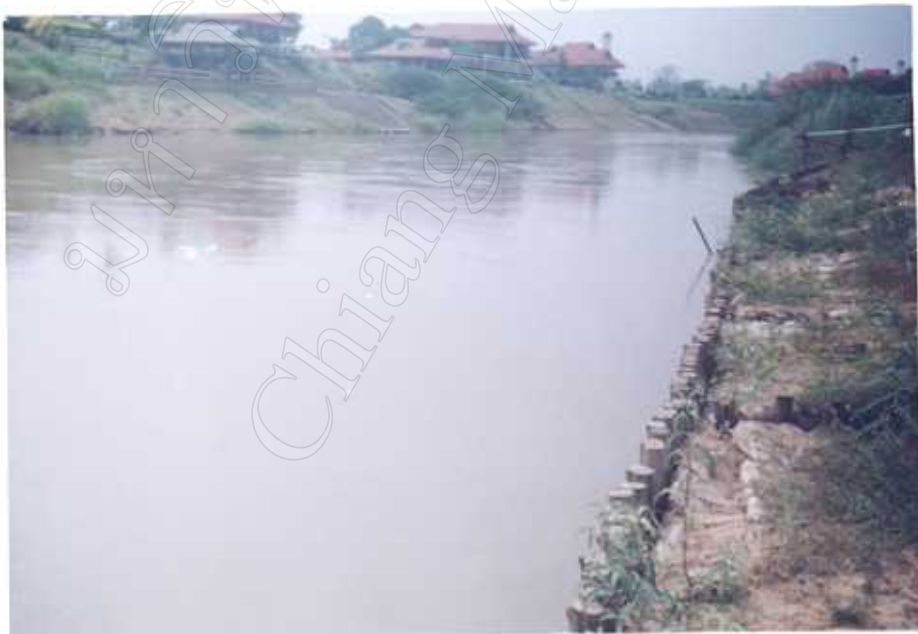
*Figure 3: River site R 1 in the Ping River. Note the poles near the bank used to hang up the Artificial Substrate Samplers*

This site is located above the Mae Kha sewage canal outfall. The surrounding area includes housing schemes and longan orchards. The bank stability is very low due to the presence of grasses and small shrubs only (Figure 3).

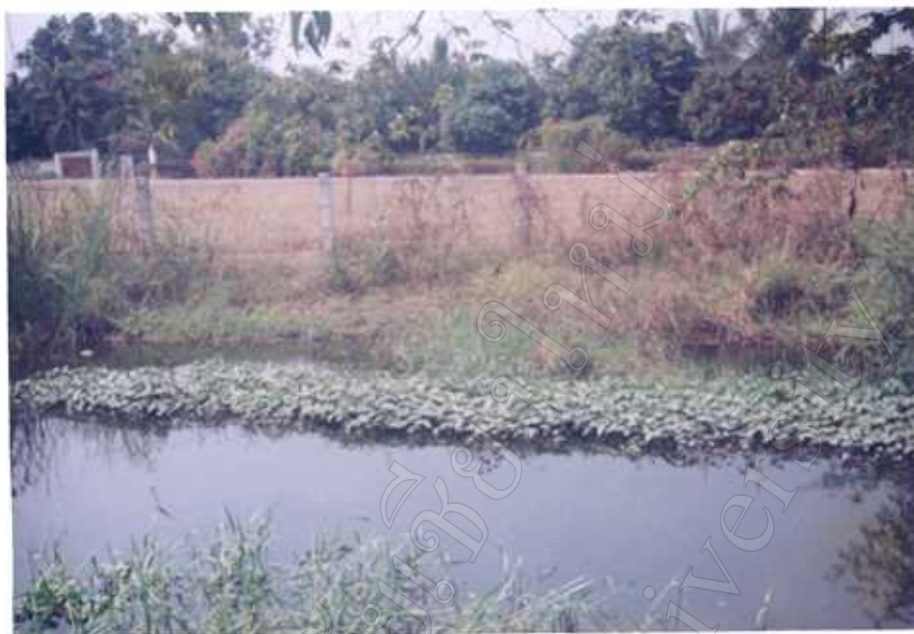
*Figure 4: Sewage canal site SC 1. Note abundant aquatic plant in the canal.*

This site is located close to the Lanna Hospital. It was selected to find out the effect of pollutant on aquatic fauna before the canal passes through the city. There is a fluctuation of water flow throughout the year and the rate of water flow is very low due to the abundant presence of aquatic plants (Figure 4).

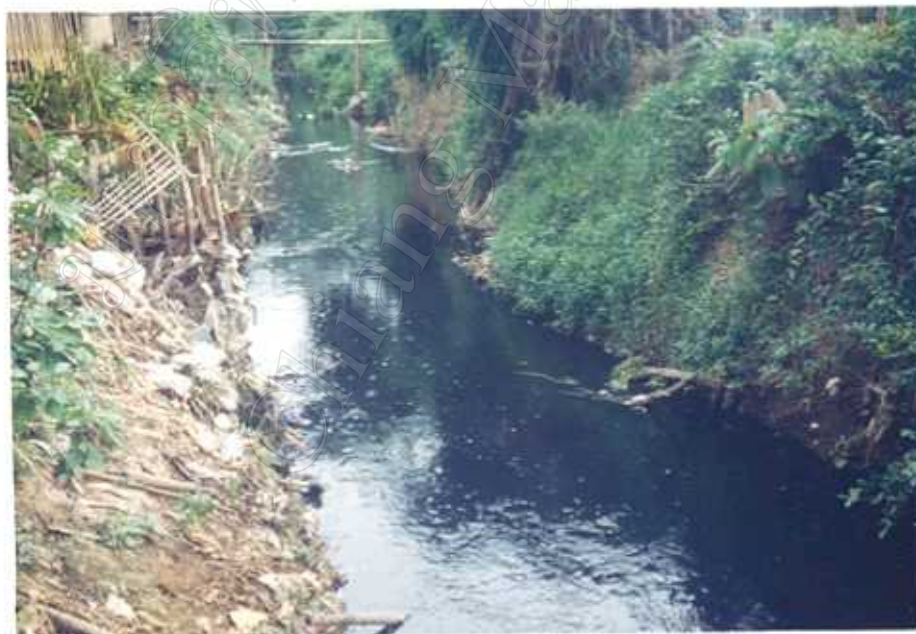
*Figure 5: Sewage canal site SC2. Note the color of water and solid wastes on the bank*

This site was located a few meters before the canal reaches the river at Ban Pa Dad, Muang district. The water is highly polluted with black substrate and with bad odour. There are longan orchards and private houses in the vicinity (Figure 5).
