DIRECT SHEAR TEST OF SOILS UNDER CONSOLIDATED UNDRAINED CONDITIONS
ASTM D 3080-90

Landslide Hazard and Risk Assessment of Doi Suthep Area

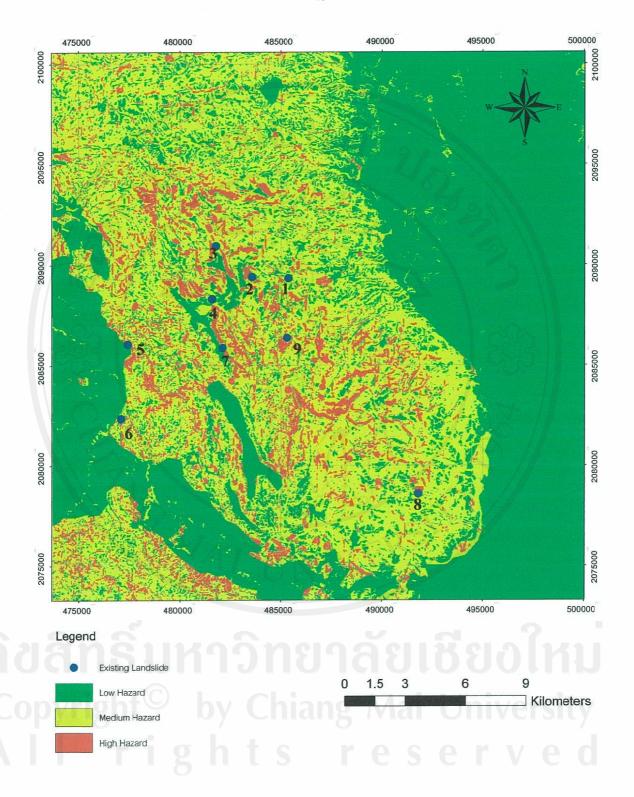
Figure 3.8 Existing landslide mapping

Landslides encountered during the field investigation are geo-referenced using Global Positioning System (GPS) and mapped in the hazard map. Slope (both natural and modified due to road cut) and landslide dimensions are measured in the field. Types of landuse were also field checked. Detailed descriptions of the prevailing conditions of existing landslides area is as shown in Table 3.4. The figure 3.8 shows the geo-referenced landslides mapped on the hazard map. Figure 3.9 through figure 3.17 shows the pictures of each landslide.

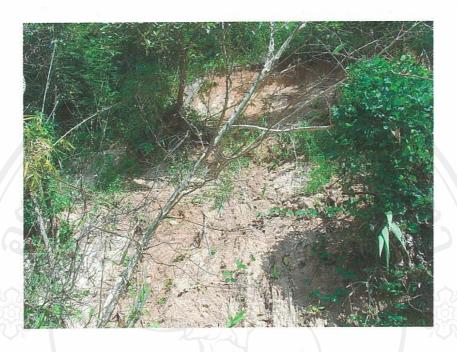
Figure 3.9 Picture of existing landslide (Landslide 1) in weathered gneiss on highway 1096 (Mae Rim-Samoeng highway)

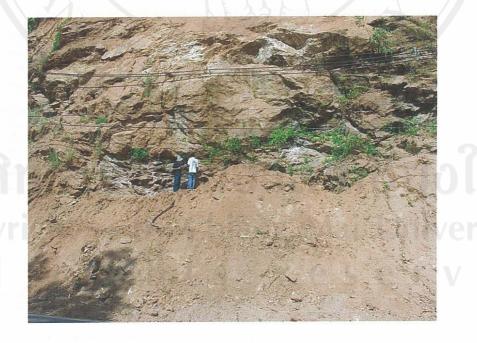
Figure 3.10 Picture of existing landslide (Landslide 2) in weathered gneiss on highway 1096 (Mae Rim-Samoeng highway) near Ban Pong Yaeng Nok.

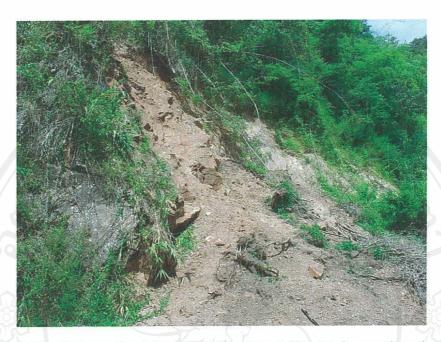
Figure 3.11 Picture of existing landslide (Landslide 3) in weathered gneiss on road leading to Ban Sam Lang

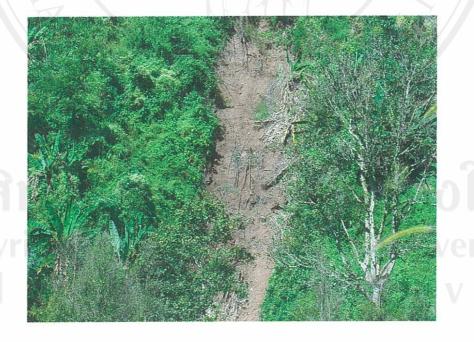
Figure 3.12 Picture of existing landslide (Landslide 4), a natural landslide in weathered gneiss near Ban Pong Yaeng Nok below highway 1096.

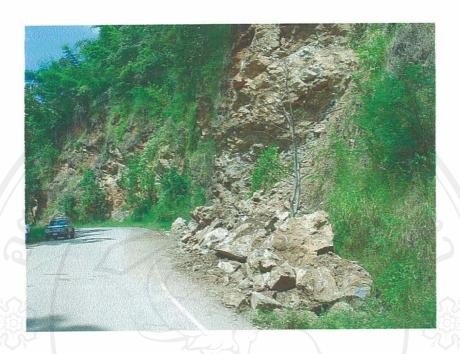
Figure 3.13 Picture of existing landslide (Landslide 5), a rock fall in limestone on highway 1096 (Mae Rim-Samoeng highway).

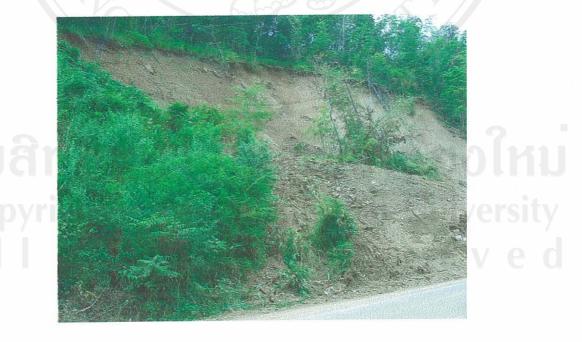
Figure 3.14 Picture of existing landslide (Landslide 6) in weathered shale on highway 1096 (Mae Rim-Samoeng highway)

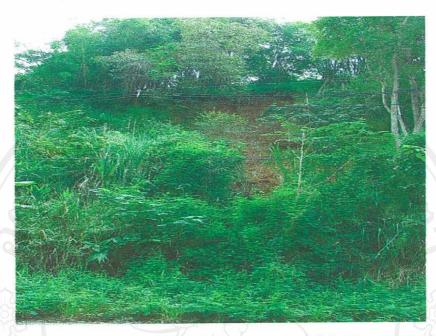
Figure 3.15 Picture of existing landslide (Landslide 7), a natural landslide in weathered gneiss above Ban Dong Nok.

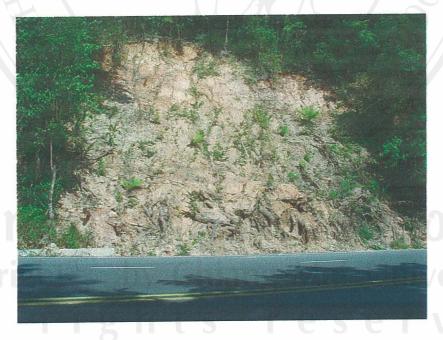
Figure 3.16 Picture of existing landslide (Landslide 8) in weathered gneiss before reaching Doi Suthep Temple.

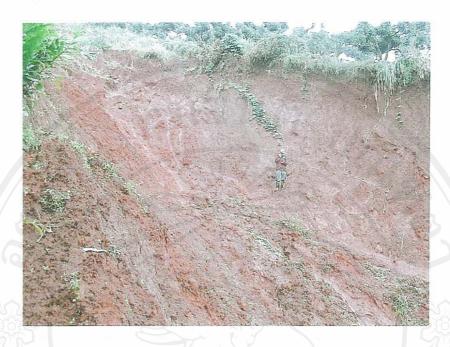
Figure 3.17 Picture of existing landslide (Landslide 9) in weathered gneiss above Ban Mae Sa. The slide occurred in August 2004.

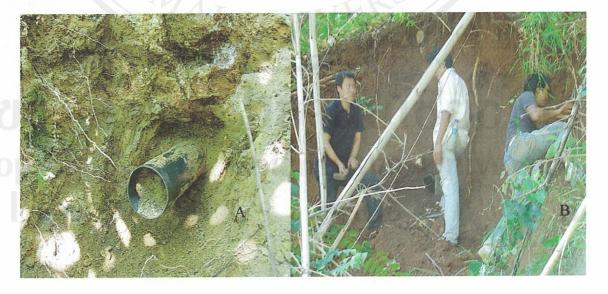
Figure 3.18 Sampling site: A – Gneiss and B – Shale, for slope stability analysis

The input parameters required for both methods of stability analysis were obtained through field and laboratory tests and from the literatures. One undisturbed soil samples each from weathered gneiss and weathered shale (Landslide No. 2 and No. 6 respectively in Figure 3.8) was collected as shown in Figure 3.18. Geotechnical parameters such as friction angle (φ) , cohesion (c), field density (γ) and hydrological parameters such as permeability were determined. Direct shear test of soils under consolidated undrained conditions was carried out to determine soil strength parameters, φ and c. The natural water content was also determined. The wet density of soil samples was obtained through field density test while dry and saturated densities of the soil samples were obtained in the laboratory. The permeability of the two soils was also measured at the sites. Rainfall data obtained from Thai Meteorological Department website was used.

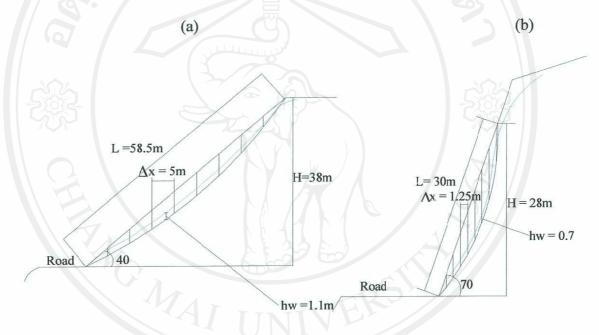
Figure 3.19 Profile of the failed slopes: a) in weathered shale b) in weathered gneiss

The analysis of failed slopes is aimed at determining the effect of water or the height of phreatic surface above the slip surface during the time of the slope failure. Geotechnical parameters required by the Janbu's method of slices were determined through field and laboratory tests. The dimensions of the failed slopes were measured in the field. The profiles of the failed slopes are shown in Figure 3.19.

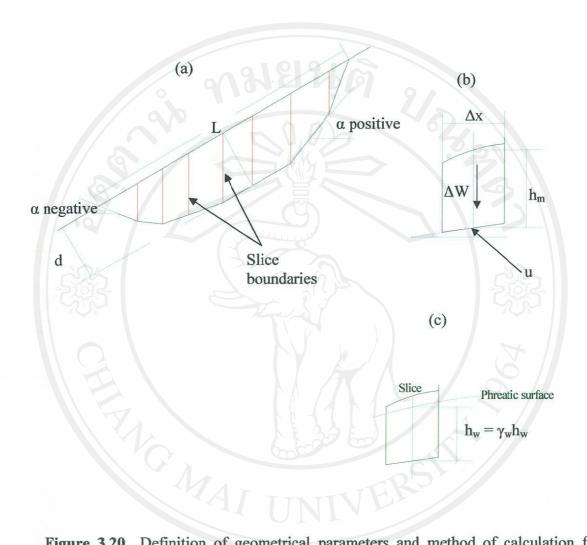
Figure 3.20 Definition of geometrical parameters and method of calculation for Janbu's non-circular failure analysis

Janbu's method for analyzing non-circular failure in slopes is one of the most versatile methods and it is simple enough to permit the solution of problems by hand. When the properties of the soil or waste rock mass vary and the slip surface is not circular as a result to some structural feature such as soil / rock interface, the Janbu's method can be used (Hoek and Bray, 1977). In this method the sliding mass is divided into a number of slices. Unlike other methods, the slices into which the sliding mass is divided need not be of constant width. The factor of safety is given by the formula:

After inputting all the parameters in the table, the iteration were performed with different values for h_w each time adjusting the factor of safety closer and closer to 1. The h_w value at the factor of safety equal to 1 is the h_w during the time of the slope failure.

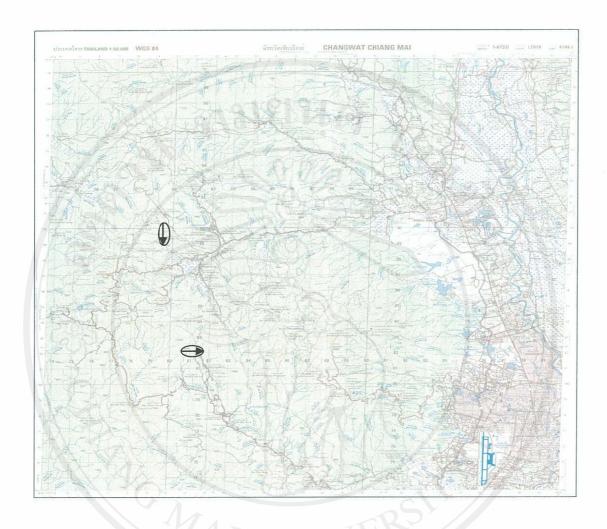
Figure 3.22 Topographic map showing the location and direction of slope under investigation.

Two natural slopes (Figure 3.22), one near Ban Pong Yaeng Nai and the other near Ban Tong Hua Hin were selected for modeling using CHASM software.

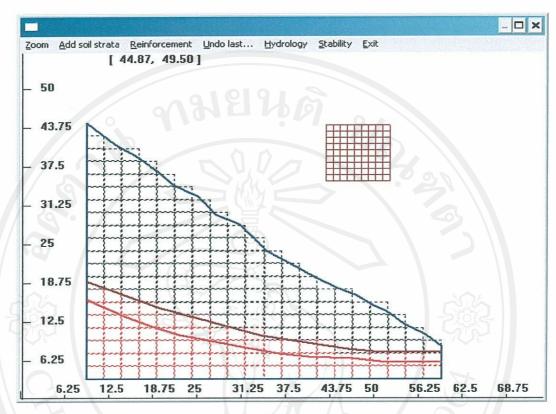
Figure 3.23 On-screen slope geometry and finite difference mesh generation

The steps outlined in the CHASM 4 HELP has been followed. First the geometry of the slope under investigation, as observed in the field and read from the topographic map was drawn using an automated mesh generator window, which allows drawing a slope profile on the screen, through a simple point and clicking operation (Figure 3.23). From the same window definition of soil layer, water table and choice of slip-circle search grid location (Figure 3.24) for the Bishop's circular stability analysis was achieved.

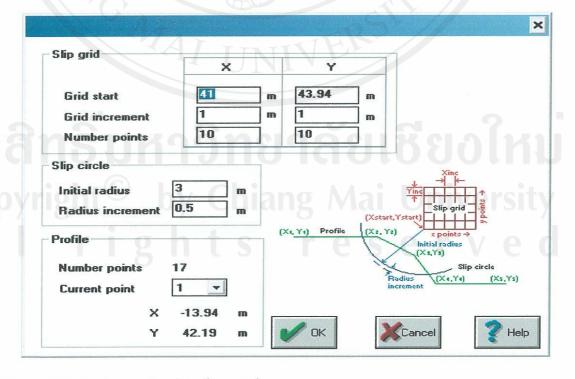
Figure 3.24 Bishop's circular slip search

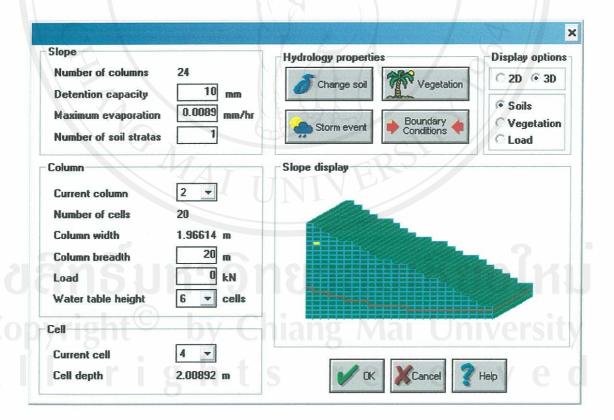
Figure 3.25 Hydrology dialog box (with 3D convergence).

The second step involved initialization and parameterization of each major component of the model including hydrology, soil and vegetation. In addition to this, other temporal and numerical information such as simulation length and iteration periods were also required. A full list of the model parameters is given in Table 3.7. Initialization and parameterization of the soil, storm and vegetation parameters were done through respective windows. The access to these parameters can also be gained through hydrology summary dialog box (Figure 3.25) which is also used to edit the slope cross- section (including three dimensional slope representations), water table height and the mesh dimension.

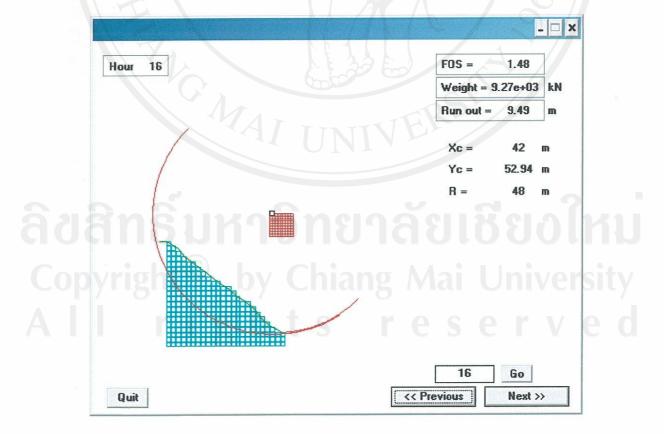
Figure 3.26 CHASM visualization of critical slip surface

On running the program from the main dialog box the option of resetting the initial moisture condition is offered. After making necessary reset the simulation was carried out. During the simulation period, a result window displays the factor of safety, the X-Y coordinates of the slip grid, the slip circle radius and mass of soil above the critical slip surface. These are displayed in real-time (i.e. as the calculations are made), so that the progress of the simulation can be monitored. Once the simulation has finished, the temporal changes in the factor of safety and the position of the critical failure surface were examined (Figure 3.26). Additionally, the spatial distribution of the soil moisture within the slope was examined at the time of the minimum factor of safety by point and click on the finite difference mesh (Figure 3.27)

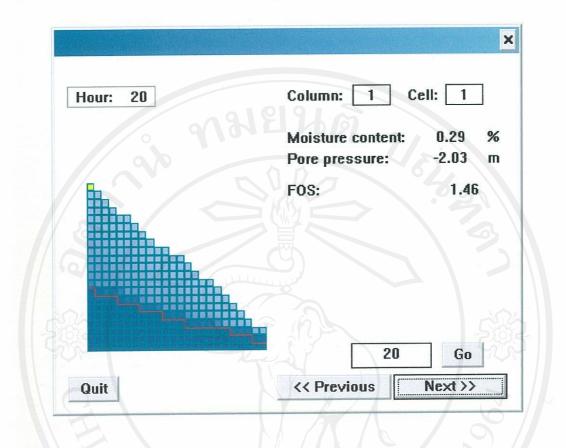
Figure 3.27 CHASM visualization of soil moisture distribution
