CHAPTER 5

Evaluation of Experimental Results

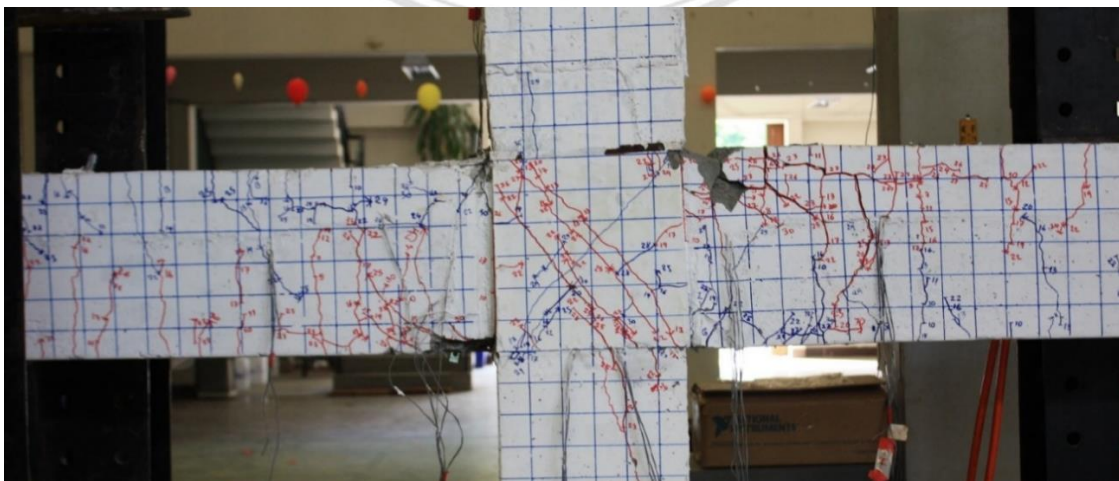
Figure 5.3 Crack distribution of precast specimen P2 at the end of testing

Due to the use of lap splice in the potential plastic hinging zones in precast specimens P1 to P4, the major failure mode progressed from tensile splitting-cracks, which developed along the splice length at the top of precast beam region in the non-shrink grout concrete region. That led to both slippage and strength degradation of the spliced reinforcement. The strength capacity rapidly decreased after the peak loading due to formation of longitudinal splitting cracks which was similar to the previous studies (Soroushian *et al.*, 1991 and Diab *et al.*, 2014) about bond behavior with high strength concrete. A number of flexural cracks were distributed over the precast concrete beams that were especially in the potential plastic hinge regions near the column. Moreover, several diagonal cracks on beam-column joint as shown in Figure 5.2 to Figure 5.5 were observed, exhibiting a combination of strut and truss mechanism under reversal cyclic displacement. Nevertheless, no crack appeared in both top and bottom columns of these

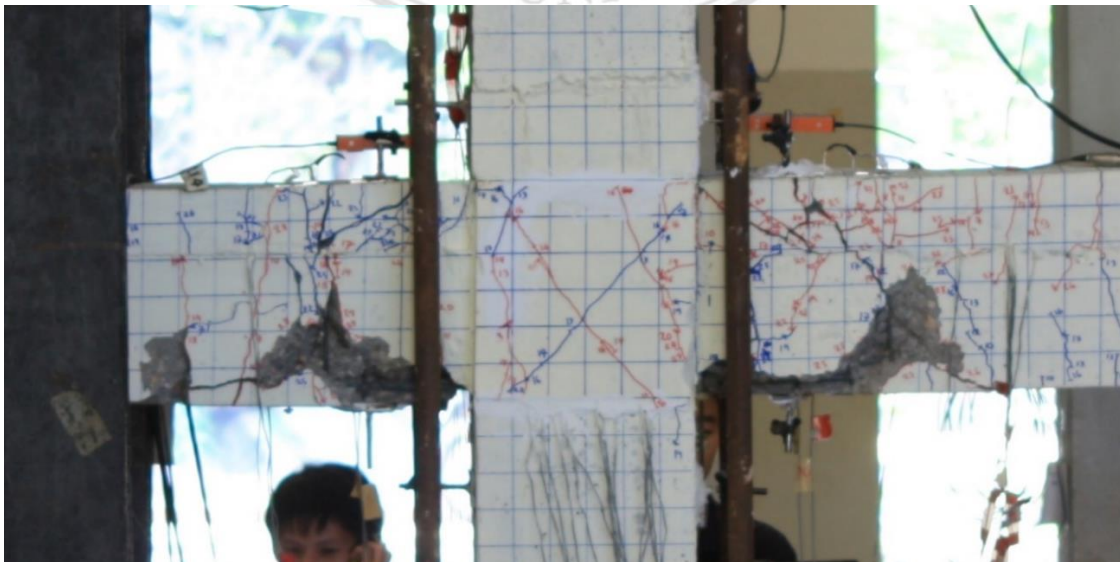
Figure 5.6 Crack distribution of precast specimen P5 at the end of testing

For the precast connection details using boule T-section steels, the cracking distribution of the precast specimens P5 and P6 after cyclic testing show in Figures 5.1(f-g) which were very similar. The relocation of potential plastic region distinctly exhibited, taken away at around distance of d from the beam-column adjacent. At the location, spalling of concrete covers spreading on the side beam surface were ostensibly observed and little splitting cracks appeared. Almost all flexural cracks diffusely appeared over the precast beams. Furthermore, there were insignificantly flexural cracks observed in the precast columns. However, there were little difference in the damaging beam region between specimen P5 and specimen P6. In regard with a diagonally cracking pattern in the joint region, the main diagonal cracks representing the strut mechanism were evidently developed in the specimen P5, but there were several diagonal cracks in other, causing strut mechanism combining with truss mechanism.

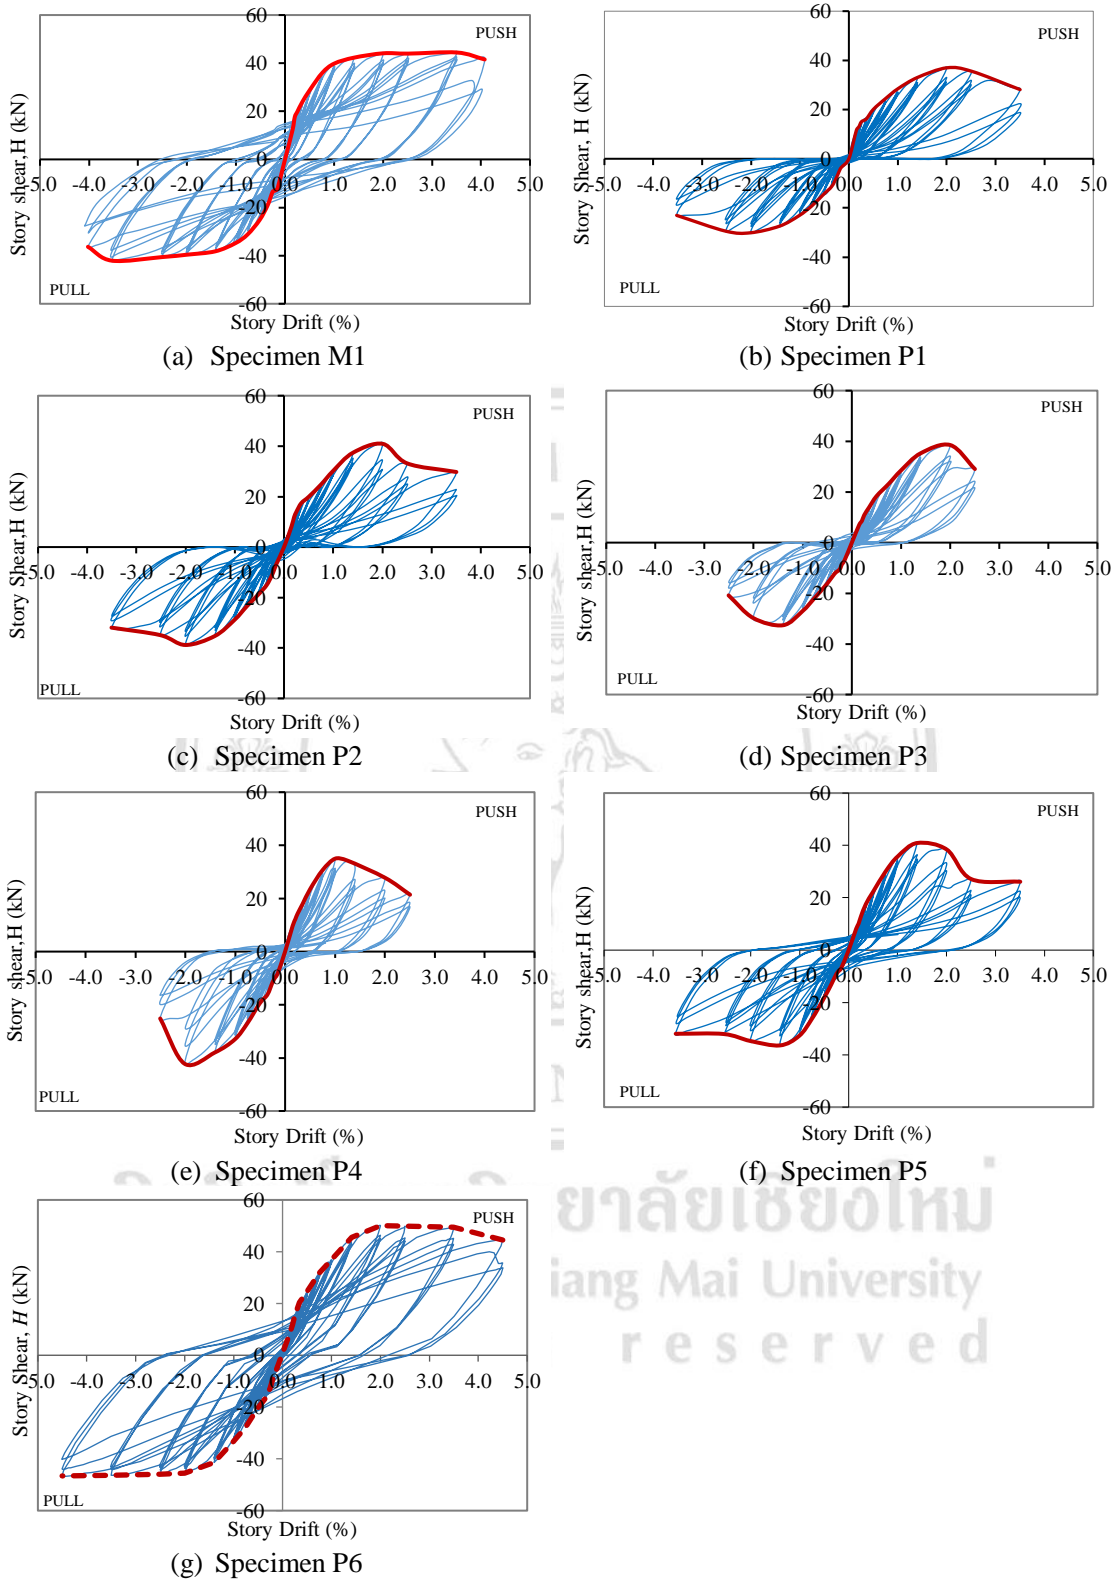
Figure 5.8 Story shear force vs. story drift ratio of test specimens

The relationship of lateral load against displacement applying at the upper column for each specimen was shown in Figure 5.8. Figure 5.2(a) illustrates the lateral story shear and displacement hysteresis response of the monolithic specimen. Because no pinching effect was observed on the reversed response, the hysteresis behavior was good in terms of energy dissipation. The shear story showed little strength or stiffness degradation until the story drift level was up to 4.00%. Nevertheless, the degradation of maximum capacities in the repeating cycle was pronounced, less than the 0.85 times of the maximum strength in the first cycle at the same drift level. Plastic hinging took place in the beams at a distance of $d/2$ from the column faces.

Regarding the P1 to P4 precast specimens, which have longitudinal lap splice bars at the top beam located at the beam end regions, a distance of $2d$ from column faces. The hysteretic load-displacement relationships of the precast specimens P1-P4 are shown in Figure 5.2(b-e). As can be seen, the hysteresis response obviously exhibit the severely

pinching effect due to splitting crack in the top of the longitudinal lap splices and bond deterioration, indicating low energy dissipation. The widening of splitting cracks in high strength non-shrink region resulted in the dramatic degradation of story shear capacity after peak loading. These precast specimens showed a limited ductile response as shown in Fig. 10 (b) to Fig. 10 (e). The maximum lateral loads of these precast ones were presented in Table 5.1. The maximum loads of specimen P1 were lower than all the other precast specimens because the distance between main longitudinal bars and steel T-section were lower compared with the other precast specimens.

For the precast specimen P5, with double T-sections installed into the top and bottom beam region, located within distance d from column faces, behaved satisfactorily. The hysteresis behavior of the specimen showed a little pinching during the reversible load testing and the considerable pinching effect occurred in the precast specimen due to the observed flexural failure in the precast beams. The failure mode represents the successful relocation of the plastic hinge in the beams. However, there were a few splitting cracks appearing at the lap splice regions in precast beam. Behavior of this specimen was good in terms of ductility and energy dissipation when compared with previous precast ones. The column story shear versus drift ratio of the specimen P5 is shown in Figure 5.2(f), the envelope curve presented the strength degradation was rapid post peak strength due to bond deterioration.

The connection detail of precast specimen P6 were improved from the P5 precast connection, without lap splice for main longitudinal reinforcement in critical beam plastic hinging zone. The hysteresis response of the specimen was very similar to monolithic specimen M1. Throughout the cyclic displacement loading, no pinching effect was observed because of without the bond problem with this precast connection, leading to higher energy dissipating than other precast connections. For the envelope curve, there was a little strength degradation after the drift ratio up to 1.40% as shown in Figure 5.8 (g). However, the maximum strength in the repeating cycle was obviously dropped, less than the 0.85 times of the maximum strength in the first cycle at the 4.50% drift level.

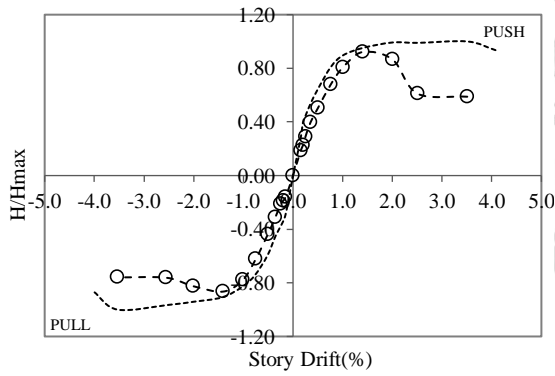
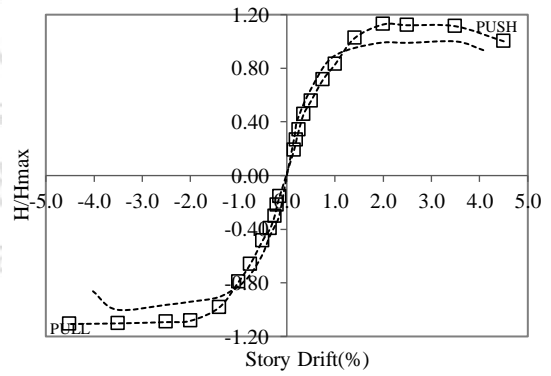
Figure 5.10 Backbone curves of the test specimens

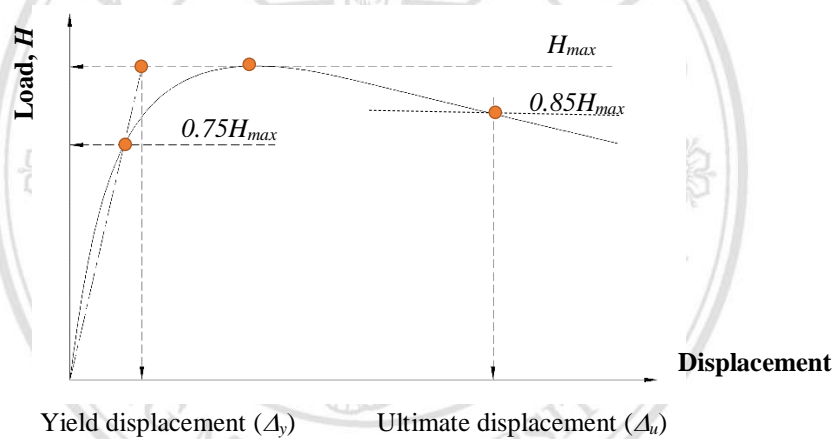
Figure 5.11 Definition for yield and ultimate displacements

The backbone curve of all specimens shown in Figure 5.9 was performed for conducting the strength and displacement ductility. As shown in Figure 5.11, the definition of equivalent yield (Δ_y) and ultimate displacement (Δ_u) as proposed by Park (1989) for the general case of lateral load-displacement responses was adopted in this study of the ductility factor. The ultimate displacement was taken as the post peak displacement with a 15 percent drop off in the maximum lateral load capacity, or the strength of the repeating cycle decreased over 15 percent of the first cycle. The use of the displacement ductility factor was used to represent the inelastic deformable of the structure during seismic loading.

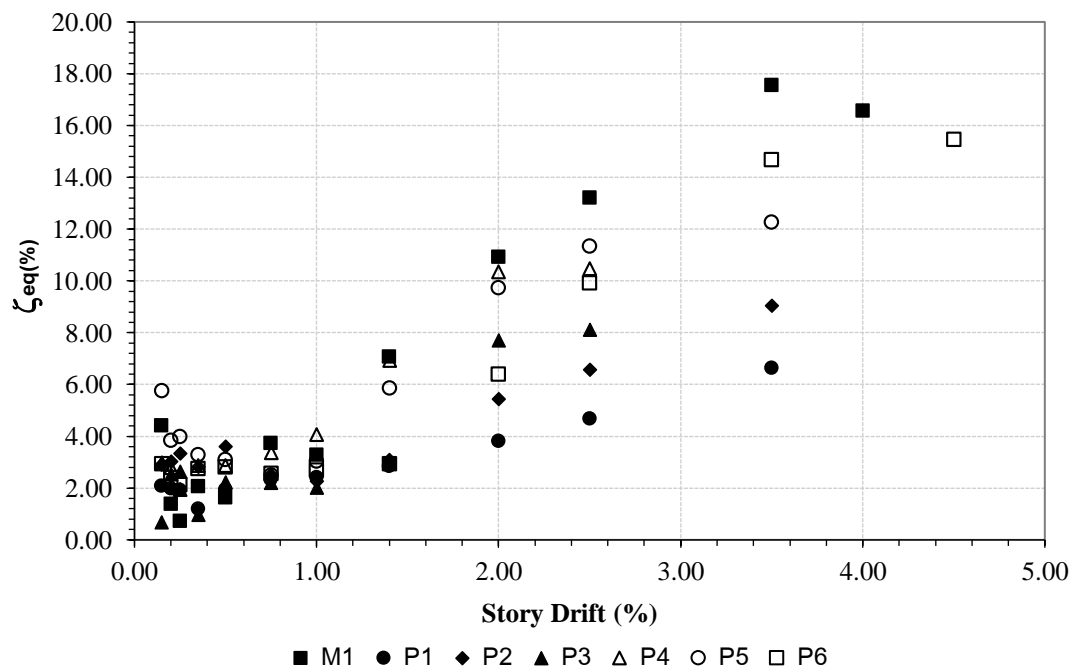
Figure 5.14 Equivalent damping ratio

The equivalent viscous damping ratio versus story drift level of all test specimens is shown in Figure 5.14. Especially higher drift level, the equivalent damping of the monolithic specimen M1 was higher than all the other precast ones. The equivalent damping response of the specimen P6 was similar to the M1 specimen; it also showed the best damping performance, comparing with the other precast. At higher drift level, precast specimens P1, P2, P3 and P4 were obviously very low due to a pinching effect during reversal movement, especially the P1 specimen designed mainly for gravity loading.

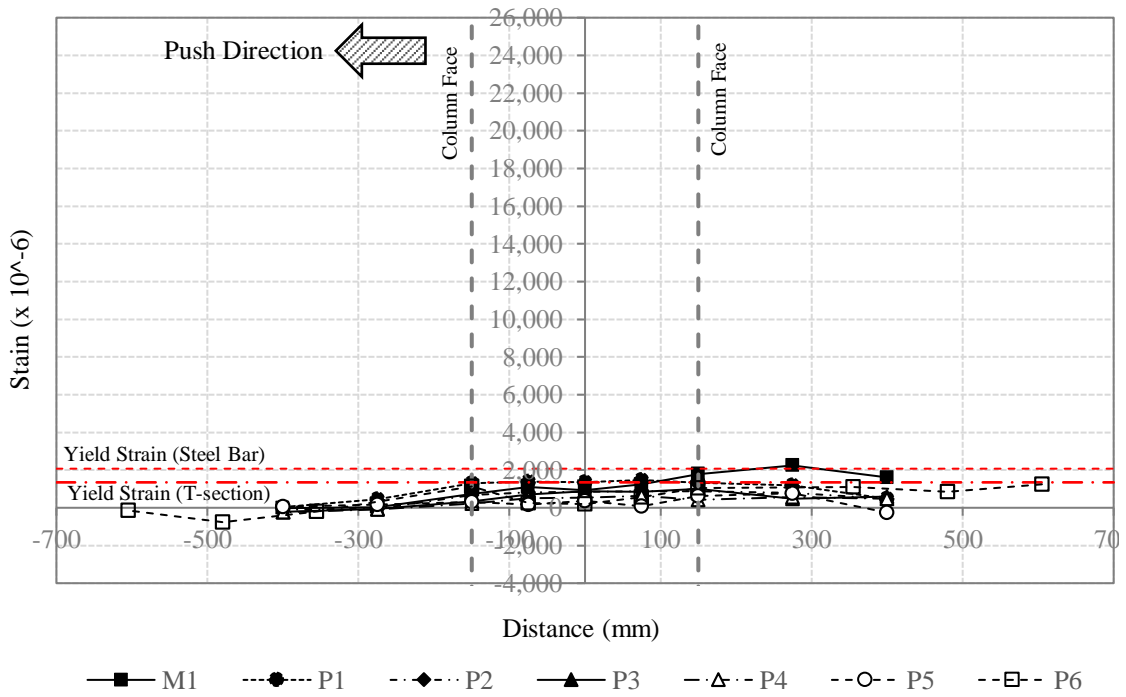
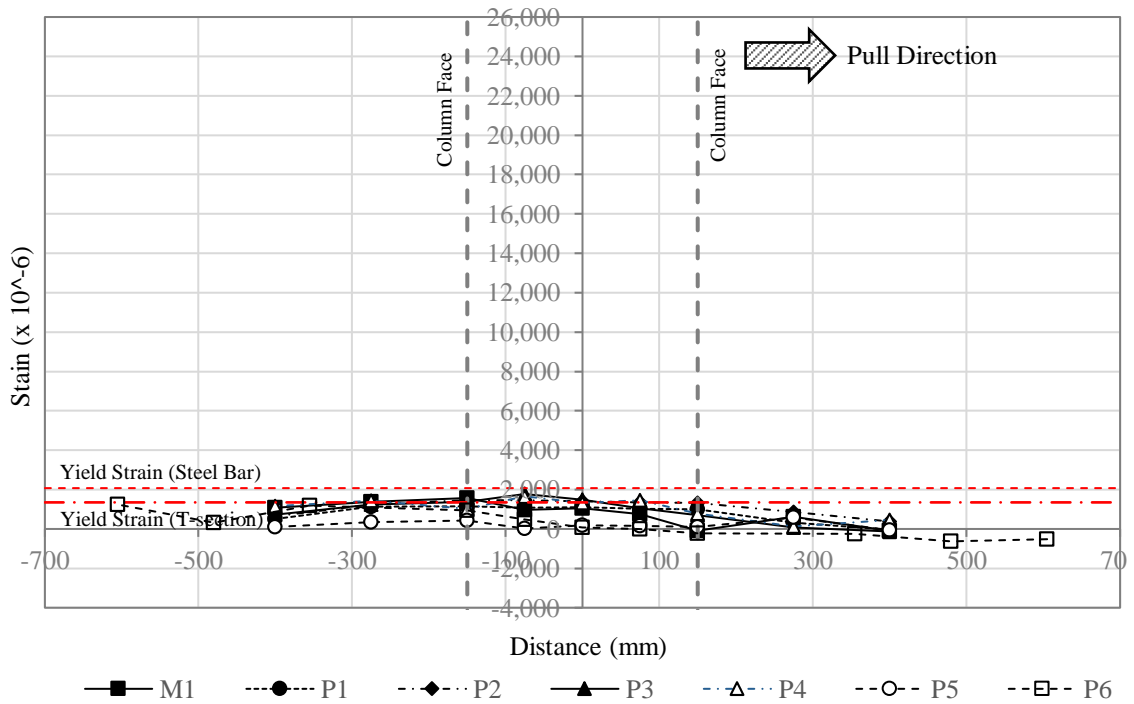
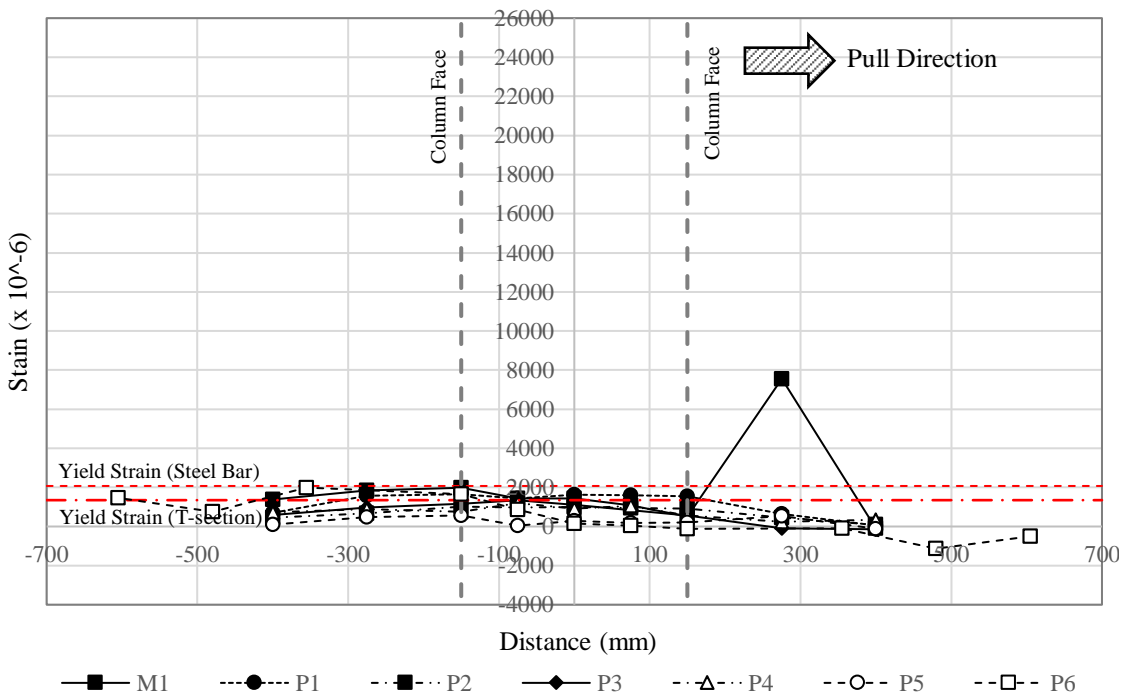
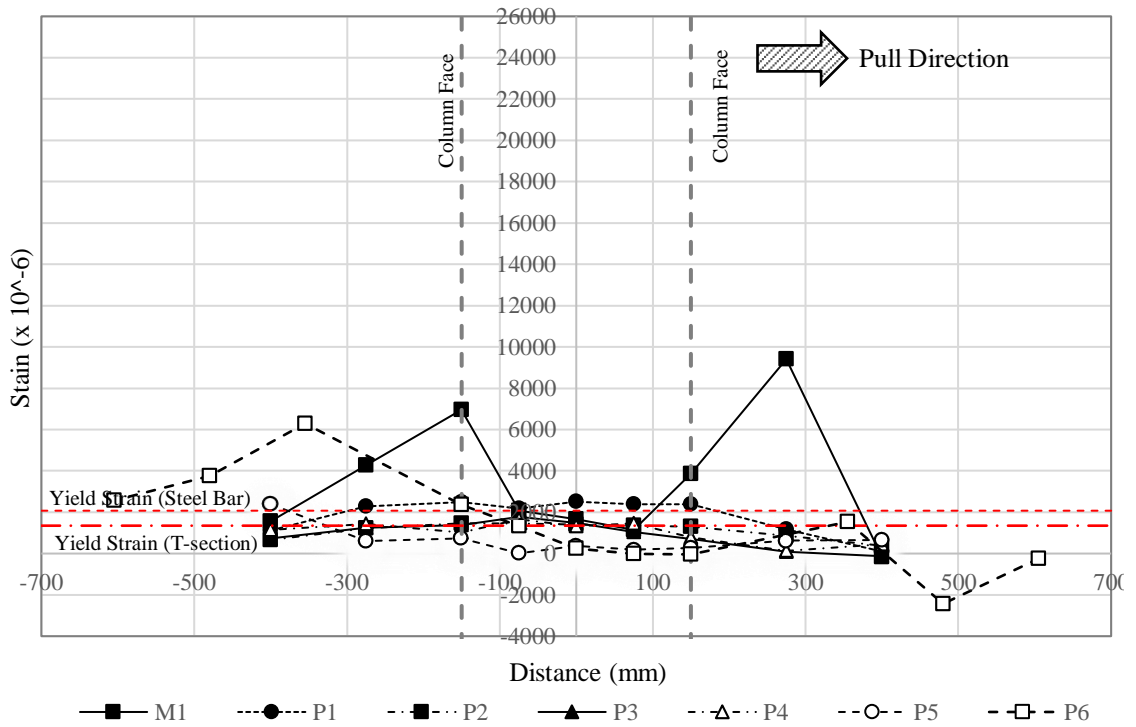
(a) Strain profile of Top reinforcement at +0.75% drift level (Push direction)

(b) Strain profile of Top reinforcement at -0.75% drift level (Pull direction)

(c) Strain profile of Top reinforcement at +1.00% drift level (Push direction)

(d) Strain profile of Top reinforcement at -1.00% drift level (Pull direction)

(e) Strain profile of Top reinforcement at +1.40% drift level (Push direction)

(f) Strain profile of Top reinforcement at -1.40% drift level (Pull direction)

Figure 5.15 Strain profile of top reinforcement

All specimens obviously exhibited a strong column-weak beam mechanism. Therefore, the longitudinal reinforcement of beam at top and bottom of the joint region were a critical location during experiment. The study explains the strain profiles at the story drift level 1.00% to 2.50%, the yield point and the ultimate point of most precast specimens, respectively. The strain profiles of the top and bottom reinforcement in the critical region at each the story drift level are explained in Figure 5.15 and Figure 5.16.

At the story drift level 1.00% as yield point of the test specimens, only reinforcement of monolithic specimen M1 rose to yield strain level. Also, the strain levels of top and bottom reinforcement of specimen M1 were up over the yield level at the beam plastic hinge zone, at 2.50% story drift. For precast specimens, the strain profiles of all precast specimens were under the yield level, at 1.00% drift level. For the strain levels of the top reinforcement compared to the yield strain of steel bar at the story drift level 2.50%, the P1 and P3 specimens were higher but the P2 and P4 specimens were lower. For the P5 precast connection, the strain levels were climbed to over the yield level both T-section steel and the embedded steel bar at the edge of the T-section. For bottom reinforcement with T-section steel insert of all precast specimens, the levels of the reinforcement were higher than the yield level. Regard to the P6 connection, the strain level of top and bottom reinforcement developed over the yield level at the drift level of 1.00% and 0.75, respectively. The peak strains of the top and bottom reinforcement are taken away at around distance of d (200-250 mm) from the beam-column adjacent. It can be concluded that the connection is successfully able to relocate the potential plastic beam region. For comparison between the P1 and P6 specimen, the strain levels in the joint region of P1 connection rose over the yield level, showing the inelastic response of the reinforcement within the joint core. On the other hand, the strain level of the P6 specimen was still in the elastic response.

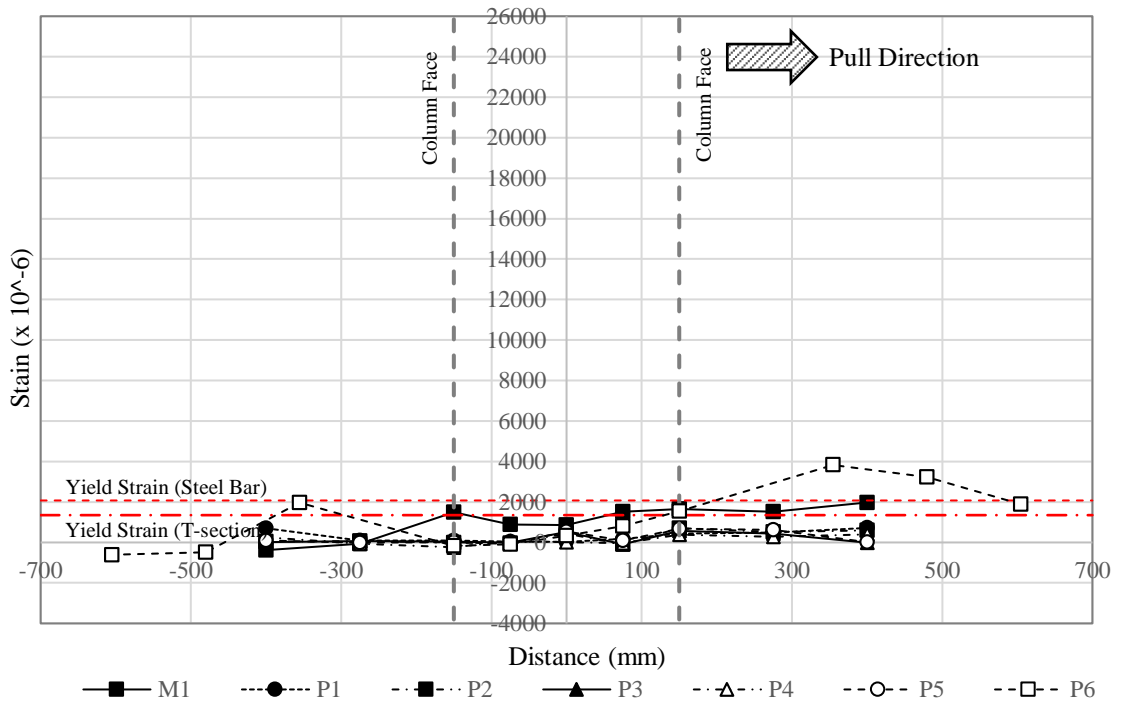
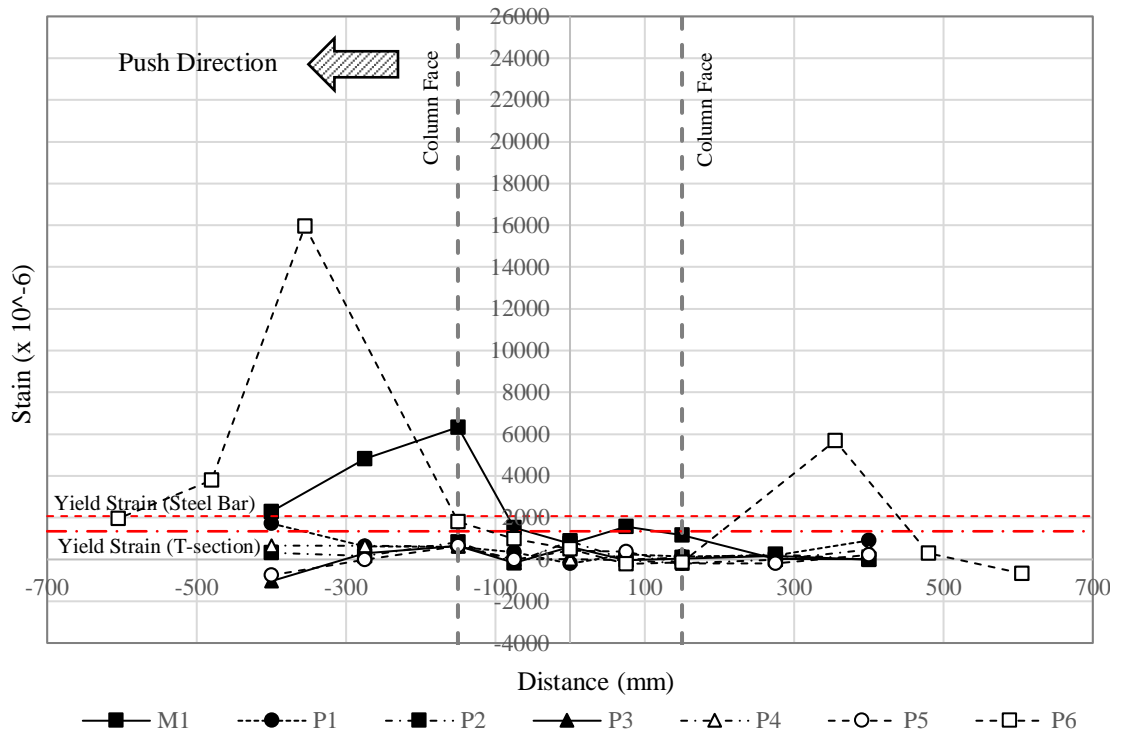
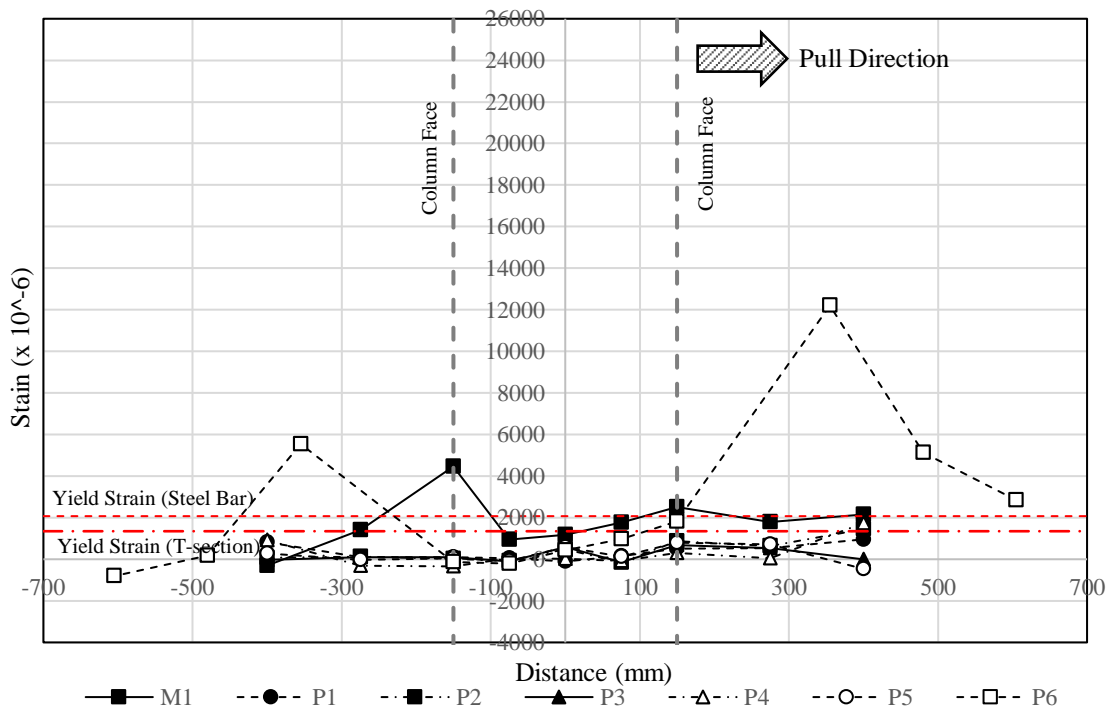
(a) Strain profile of bottom reinforcement at +0.75% drift level (Push direction)

(b) Strain profile of bottom reinforcement at -0.75% drift level (Pull direction)

(c) Strain profile of bottom reinforcement at +1.00% drift level (Push direction)

(d) Strain profile of bottom reinforcement at -1.00% drift level (Pull direction)

Figure 5.16 Strain profile of bottom reinforcement
