## CHAPTER 4

### Experimental Results

#### 4.1 Crack development

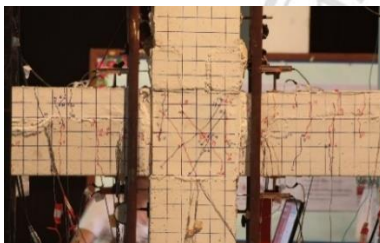
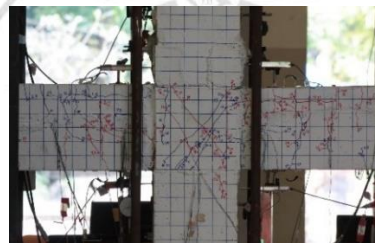
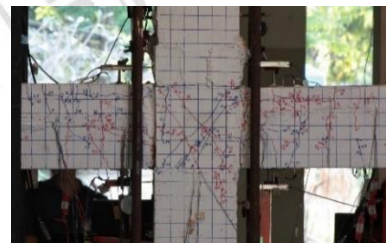
(b) Specimen P1

the column face resulted in a dramatic decrease in the shear capacity. Figure 4.1(b) shows the crack patterns of specimen P1 during the cyclic loading test.

Drift ratio = 1.00%

Drift ratio = 2.00%

Drift ratio = 2.50%

For the Gravity precast concrete connection specimen (P1), laterally splitting cracks running parallel to the T-section steel, installed at the middle beam depth, close to column face started at the 1.00% drift level. When the drift level was increased to 1.40%, the first splitting cracks formed at distances of  $d$  from the column faces along the lap-splices of the main longitudinal bars at the top section of both beams. By increasing the drift level up to 2.00-3.50%, the splitting cracks were gradually propagated and opened wider than 2.0 mm. In addition, the new flexural cracks on both beams were distinctly observed at the potential plastic hinge regions near column face and no cracks appeared in the column. The splitting cracks at the top and middle of the beam cross section near

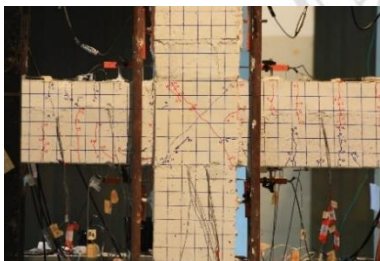
(c) Specimen P2

In specimen P2, at a drift level of 1.00% visible lateral cracks were observed at the bottom of both beams and the joint core at the beam-column interface. A few splitting cracks appeared parallel to lap-splices and main longitudinal bars at the top beam section, which were initiated at distances of 250 mm ( $d$ ) away from the column faces. When increasing to a drift level of 1.40%, cracks were gradually propagated along the lateral directions, as the drift levels were increased. When the drift level reached to 3.50%, the concrete of the top beam section close to the beam-column joint started to crush and spall along the splitting crack. Similar to specimen P1, no cracks appeared on either the top or bottom columns, as shown in Figure 4.1(c).

Drift ratio = 1.00%

Drift ratio = 2.00%

Drift ratio = 2.50%

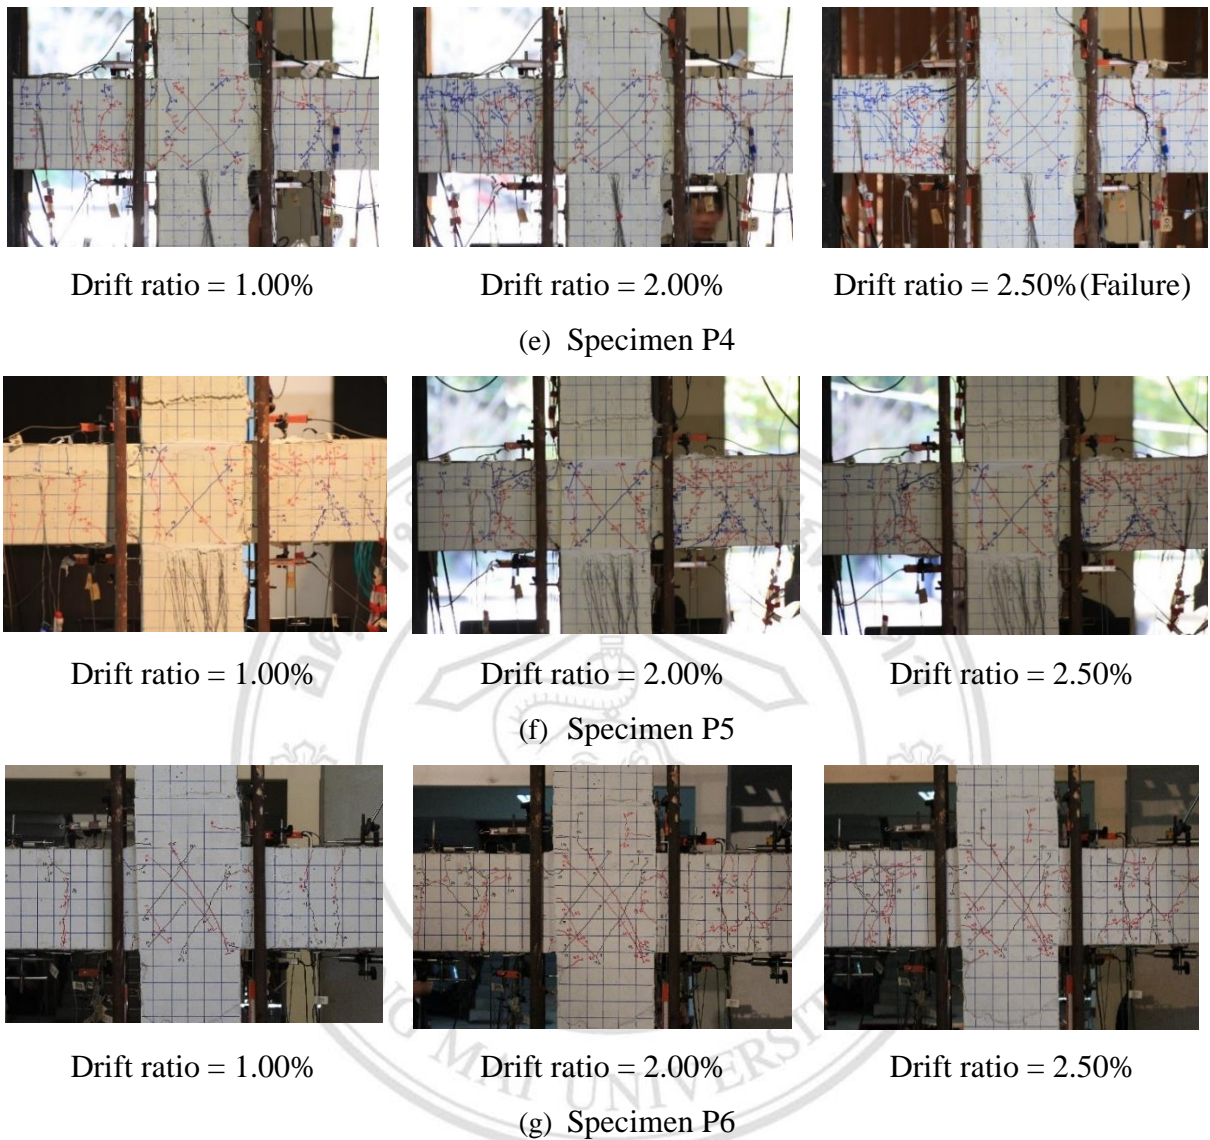
For specimen P5, the splitting cracks appeared parallel to the steel T-section and the main longitudinal bars were initiated at the bottom beam section close to the column faces, as the drift level increased to 1.40%. With the increase in the drift level the splitting cracks further propagated. The concrete below the T - section steel at the bottom beam section close to the beam-column joint were crushed and spalled. At a distance of about the beam depth from the column face of both precast beams the flexural cracks were very large. Figure 4.1(f) shows the crack distribution of the specimens after testing.

the first cycle of the 4.50% story drift level, concrete beam structures at the edges of T-section were separated due to the flexural crack opening. Afterward, the spalling of concrete cover on the top and bottom beam regions and other spalling of concrete cover spread on the beam surfaces at the location were pronounce as shown in Figure 4.1(g).

Figure 4.1 Crack patterns of all specimens

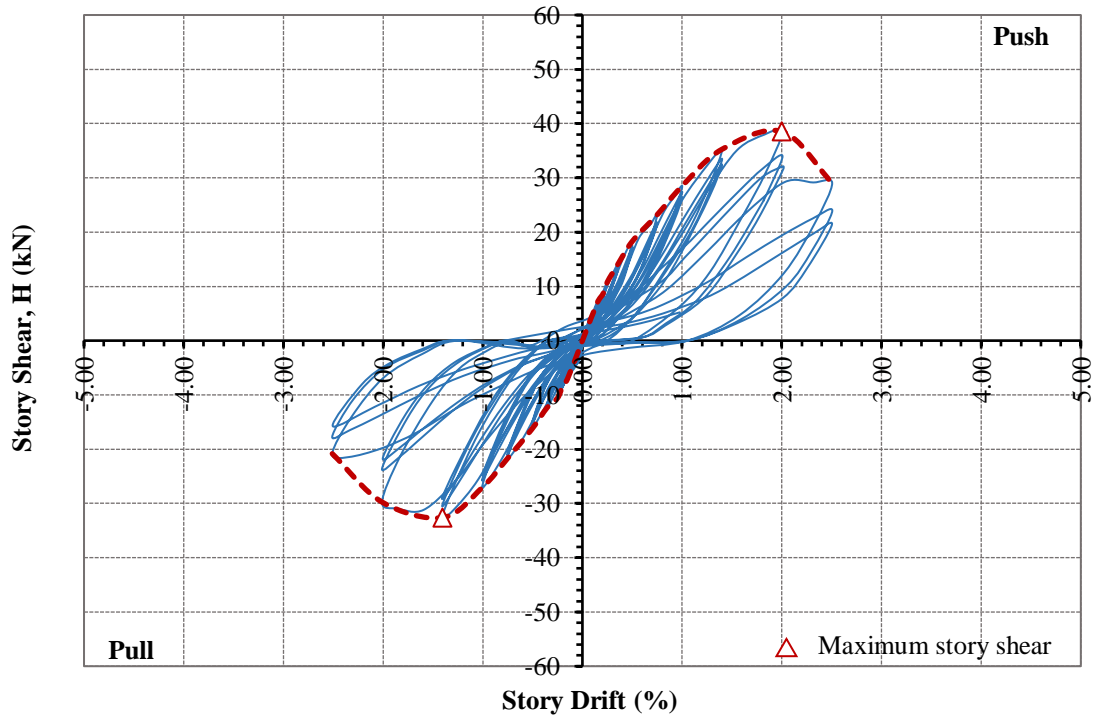
zone, the laterally strength capacities of a whole sub frame structure rapidly degraded after the peak load. A severe pinching effect shows in the hysteresis loop throughout the reversed cyclic response, exhibiting in Figure 4.10. The peak strength capacities were 38.52 kN and 32.63 kN for push and pull directions respectively.

Figure 4.10 Story shear force vs. story drift ratio of specimen P3

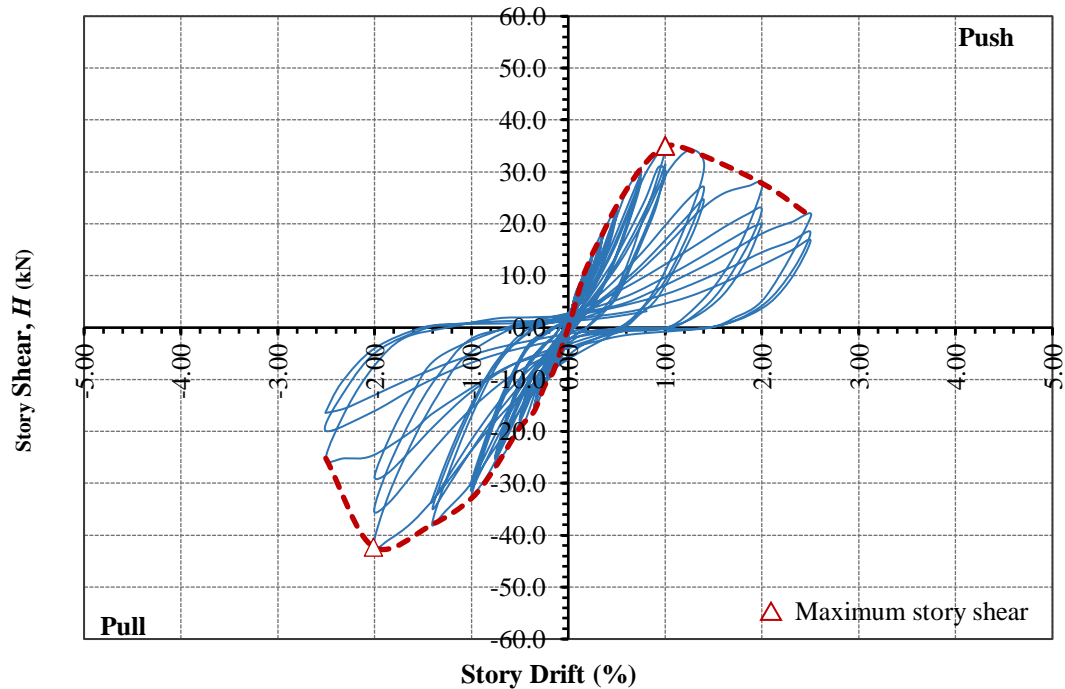
During the quasi-static testing of the precast specimen P4, first flexural cracks on both precast beams were observed at the  $d/2 - d$  distance from the column faces while the drift level grew up to 0.15%. A diagonal crack first appeared on the joint region at the 0.25% drift level. At the drift ratio of 0.75%, the horizontal cracks were investigated on the bottom beam region which these cracks penetrated into the joint region. The overall behavior of P4 specimen was very similar to that of P3 specimen up to the 1.00% story drift. During the drift levels reaching to 1.40%, splitting cracks on top and bottom beam regions were dramatically propagated. The additionally diagonal cracks were also observed over the joint region. At the 1.40% drift level, there were a few spalling of concrete cover on the bottom beam section at the column face. While the drift ratio played at the level of 2.00%, the splitting cracks along to lap splice on the high strength grout zone and the flexural cracks on the precast beam at the distance of  $d$  from the column faces were opened which were wider than 2.0 mm as shown in Figure 4.11. After that level, the lateral strength degradation in pull direction was more accelerated and pronounced, compared to the P3 precast specimen as shown in Figure 4.13. The

hysteresis response was very similar to the P3 precast specimen, showing the severe pinching effect throughout the reversed cyclic loading. The maximum loading capacities were 34.98 kN and 42.13kN for push and pull direction respectively. Figure 4.12 shows the crack distribution after the cyclic testing.

Figure 4.13 Story shear force vs. story drift ratio of specimen P4

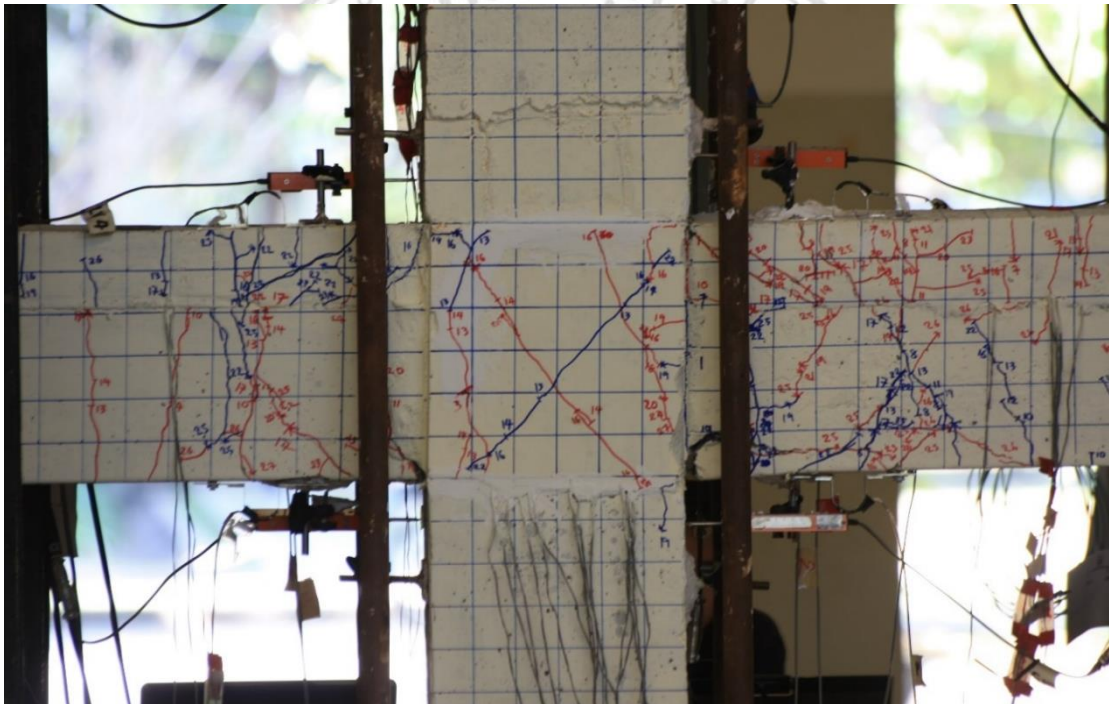
Figure 4.14 Crack distribution of specimen P5 at 1.75 percent story drift

For the development of crack pattern during the cyclic quasi-static test of specimen P5, the first flexural crack was an interface crack observed along beam depth at the column face at the first cycle of the testing. At the 0.20% story drift level, the flexural cracks were developed on the beams at a distance of  $d$  from the column faces. Also, a few vertical cracks were first observed on joint core. There were a few diagonal cracks developed on the beam-column joint at 0.50 % drift level. During the story drift up to 1.40%, those flexural cracks over the beam, the vertical crack and diagonal cracks on the joint region gradually propagated. When the drift level was increased to 1.40%, the spitting cracks along to T-section steel and lap splice bars were initiated on the top and bottom beam region from the column face to the beam elements as shown in Figure 4.14. With the increase in the drift level runs, the spitting cracks further propagated until the concrete cover at below the T - section steel on the bottom beam region close to the beam-column joint were spalled which had direction coincidental with the spitting cracks corresponding to a drift level of 2.50%. At a distance of around  $d$  from the column face of the both precast beams, the concrete beams were separated from the flexural cracks with 1.0 mm width; moreover, spalling of concrete cover spread on the beam surfaces at

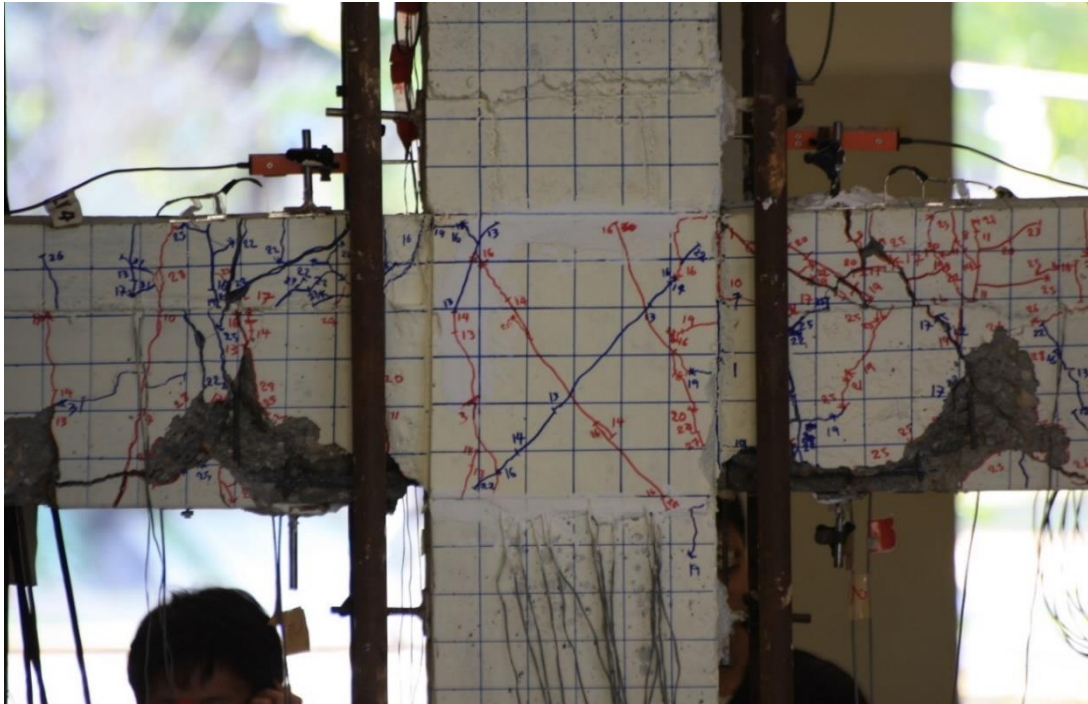
the location. Figure 4.15 shows the crack distribution of the specimen after testing. The plastic beam hinges were taken to distance of around  $d$  from the beam-column interface. Furthermore, the bond problem was observed by showing in the spitting crack pattern on the bottom beam region (below T-section steel connected to longitudinal beam bars) and a behavior of the backbone curve after the ultimate loads as shown in Figure 4.16. The recorded maximum capacities for push and pull directions were 40.92 kN and 36.82 kN respectively. The hysteresis loop showed a moderate pinching effect throughout the reversed cyclic response.

Figure 4.15 Damage level of specimen P5 at 3.50 percent story drift

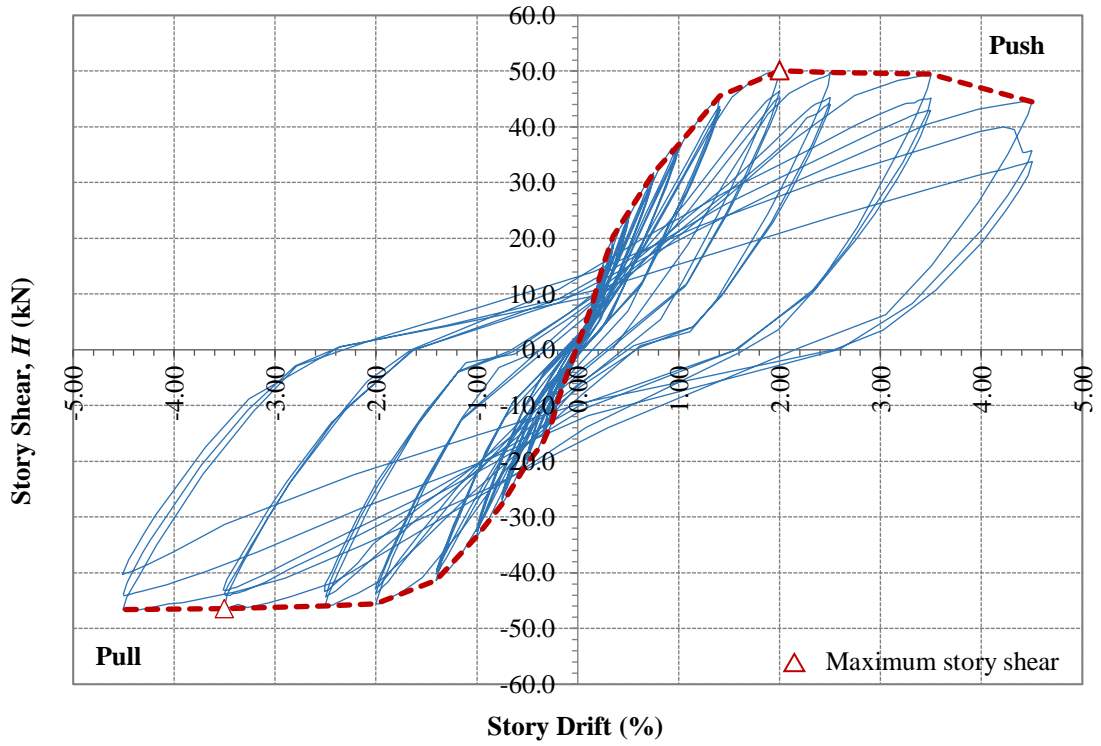
At the first drift level, the flexural cracks on both beams were observed in the location around the  $d-2d$  distance from the column faces. The first flexural crack at the beam-column interface was developed, when the story drift was at 0.20%. At the drift level of 0.35%, a diagonal crack in the joint region obviously appeared. During 0.50%-1.00%, several flexural cracks were well distributed over the beam region at the distance of  $d-2d$  from the beam-column adjacent. There were another diagonal cracks appearing in the joint core, representing a combination of diagonal strut and truss mechanisms. First diagonal cracks on both precast beams located about 30 cm away from the column face were observed at the 1.40% story drift. At the 2.00% drift level, there were horizontal cracks in level of cover concrete on top beam region, located around the distant  $d$  away from the precast column. A few spalling concrete cover in bottom precast beam region were investigated located around 20-25 cm away from the column face at the story drift level of 2.50%, coinciding the edge of T-section steel insert in precast beams. When the drift level reached 3.50%, the flexural cracks of beam elements located around 20-25 cm away from the column face were opened approximately 2.0 mm width, widening of the cracks accelerated at repeated cycle in the same drift level. Also, the horizontal cracks wider than 2.0 mm further propagated, running from the column face along 25 cm to the flexural beam cracks as shown in Figure 4.17. At the first cycle of the 4.50% story drift level, concrete beam structures at the edges of T-section were separated due to the flexural crack opening. Afterward, the spalling of concrete cover on the top and bottom beam regions at the location was observed. With the quasi-static test in the last cycle as shown in Figure 4.18, other spalling of concrete cover spread on the beam surfaces at the edges of T-section region. The critical beam region was successfully moved approximate one effective beam depth away from the column faces. Regard to the crack pattern in the precast column elements, there were a few flexural cracks appearing at the interfaces of beam and column. Figure 4.19 shows the hysteresis behavior and envelope curve of the P6 precast specimen. The hysteresis response was very similar to monolithic specimen M1. There was no observation of pinching effect throughout the reversed cyclic response. The ultimate lateral load capacities for push and pull directions were 50.07 kN and 46.60 kN respectively.

Figure 4.19 Story shear force vs. story drift ratio of specimen P6
